**BCP Council**

# Timber groynes

Evaluation of basralocus after 10 years in service

1286363-01 (00)

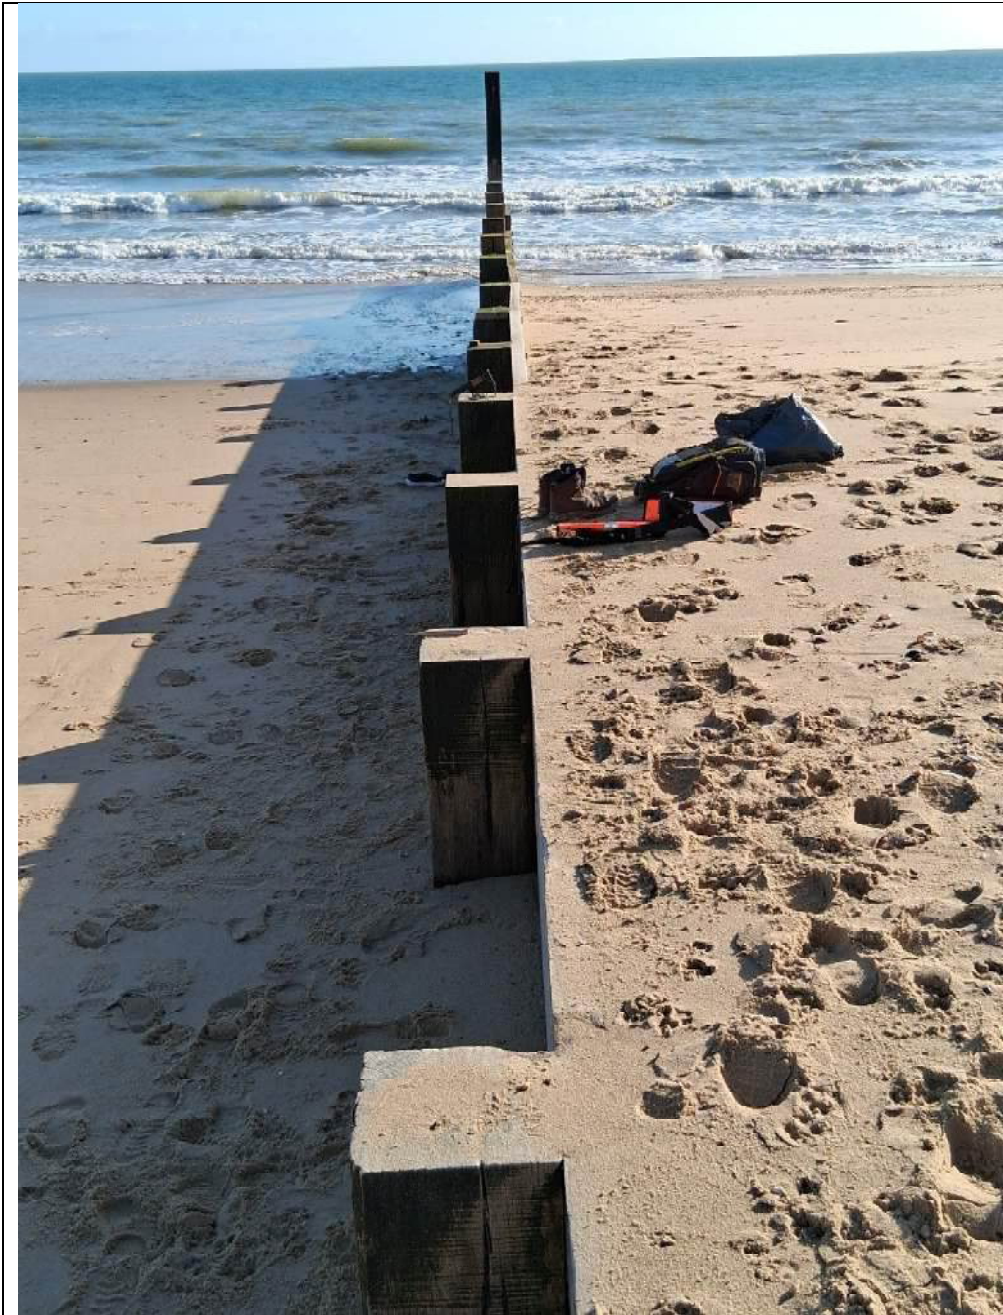
**Plate 1** - Groyne C36. General appearance looking along the line of the piles. There was no evidence of movement away from the vertical, which indicated that none of the piles at the seaward end of the groyne had suffered mechanical failure below the beach level.

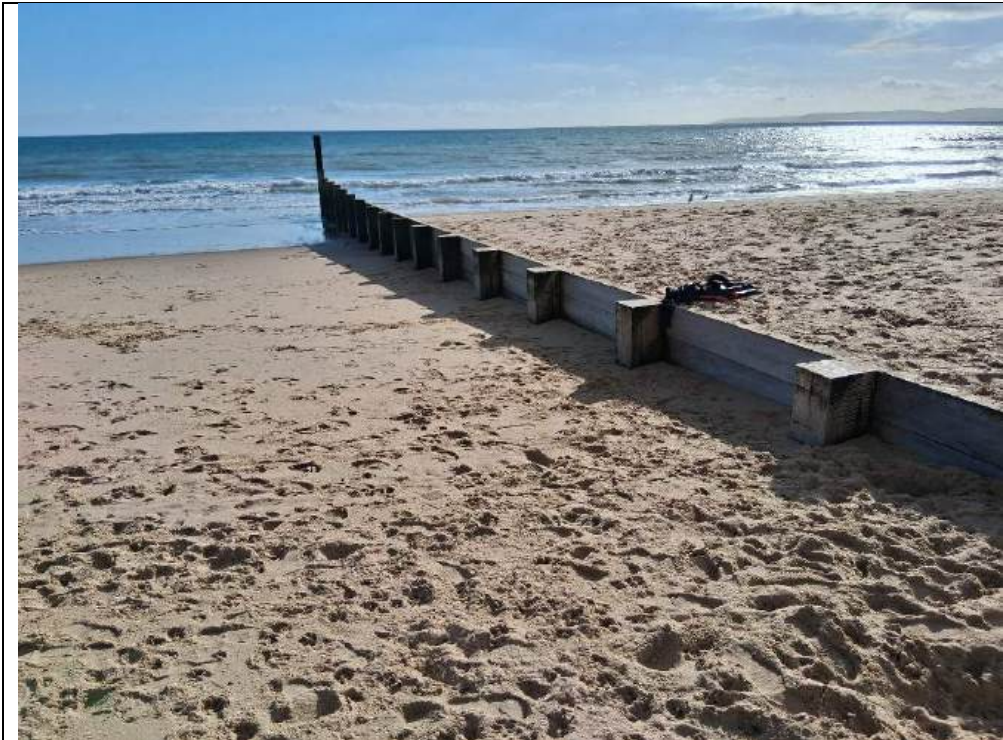
**Plate 2** - Groyne C36. General appearance viewed from the downdrift side, illustrating the difference in beach levels between updrift/downdrift faces of the groyne

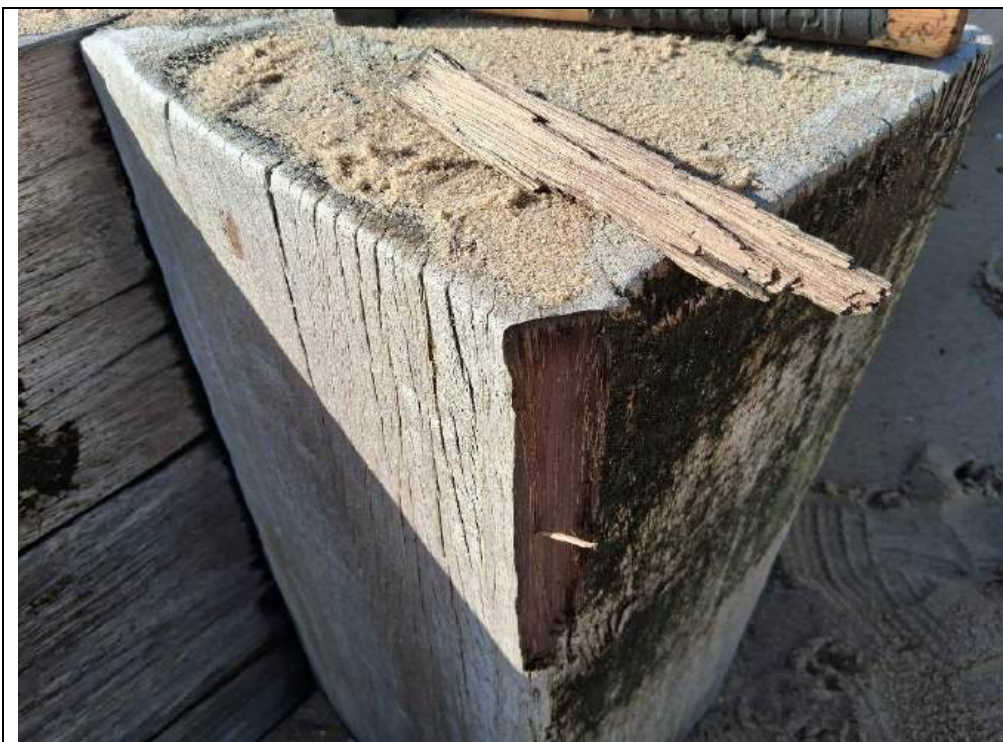
**Plate 3** - Groyne 36: Removal of pile edge to examine the timber characteristics to confirm the piles comprised basralocus. This was also confirmed by measuring the cross section, which exceeded the standard 300 x 300 mm pile section for greenheart piles. A larger 330 x 330 mm cross section was selected to counter the reduction in strength of basralocus (D50 est.) when compared in greenheart (D70).

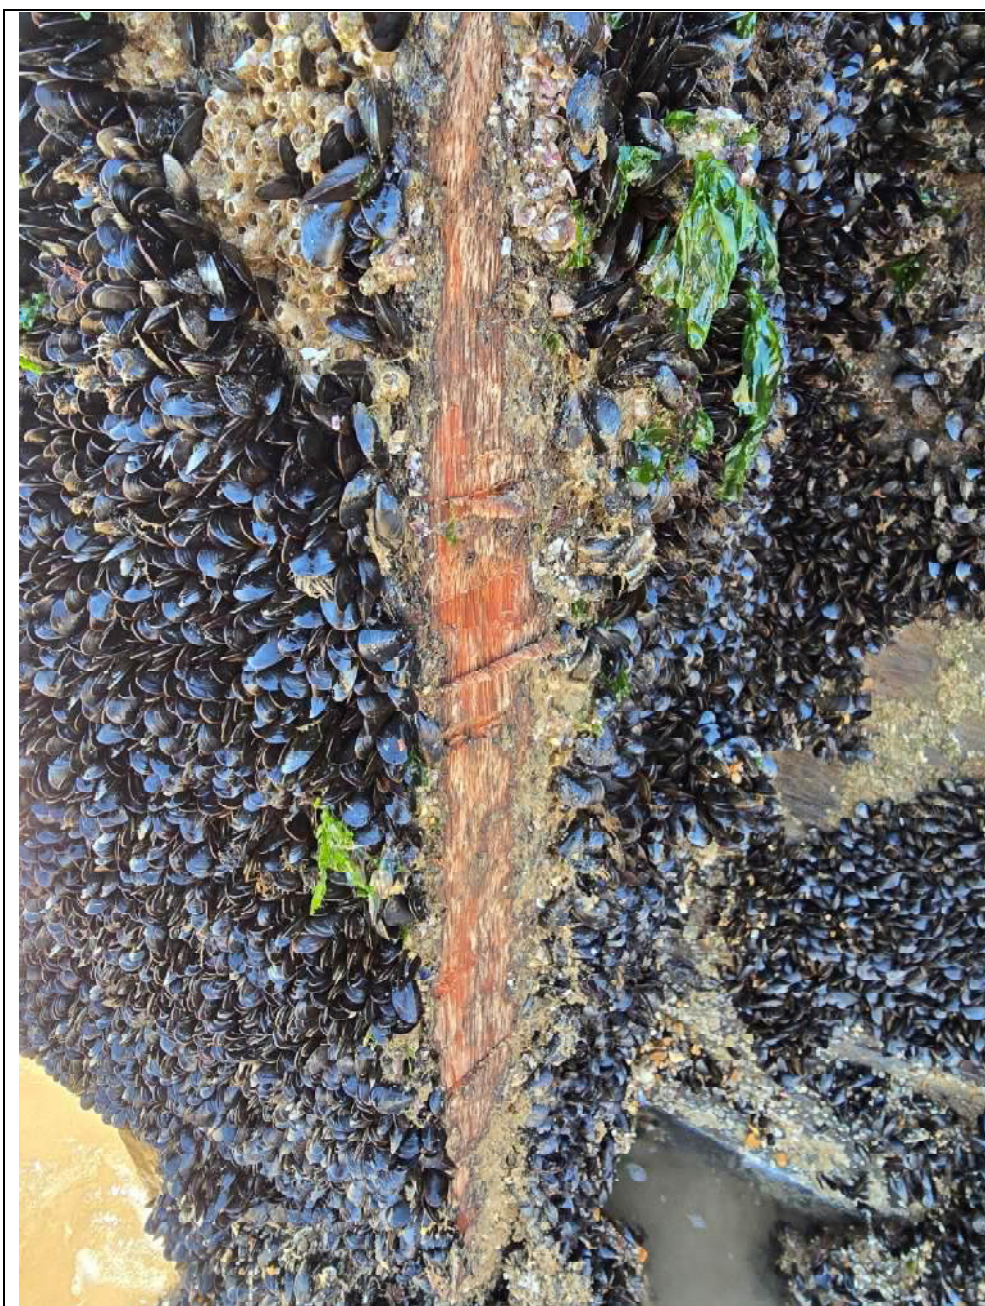
An edge was removed from piles 1 and 3 to expose about 500 mm of timber on each. There was no evidence of 'shipworm' attack in the exposed timber (**Plates 4 and 5**). However, there was damage caused by gribble at numerous positions on the groyne between piles 1 and 10, typically where the plank was in contact with the updrift and landward faces of the piles (**Plates 11, 12, 13 and 14**).

**Plate 4** - Groyne 36. Pile 1 (King pile) No evidence of shipworm.

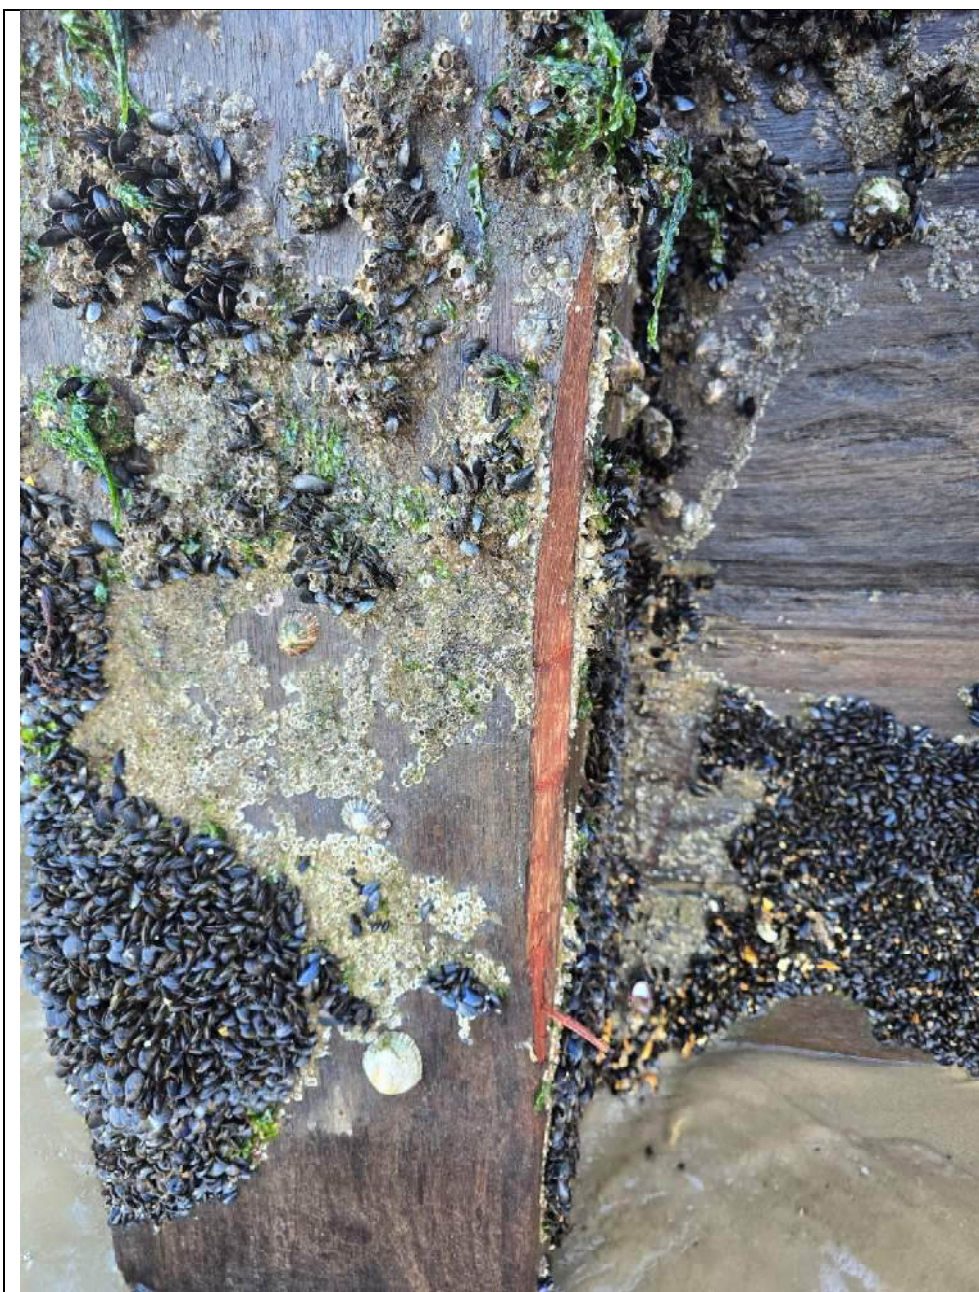
**Plate 5** - Groyne 36. Pile 2. No evidence of shipworm.

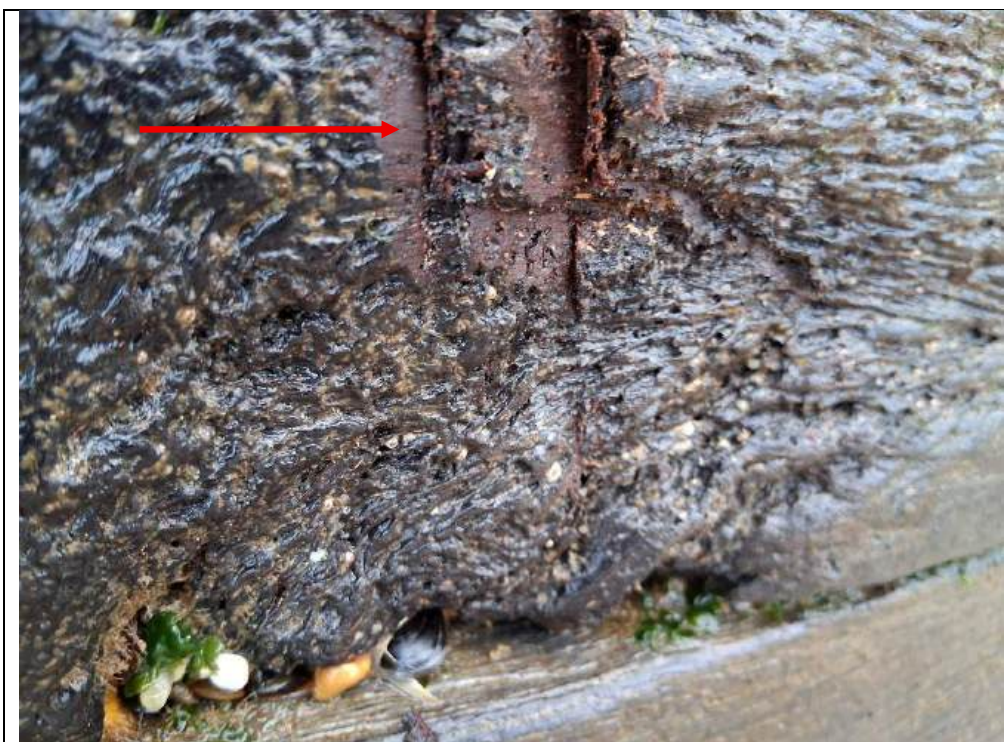
**Plate 6** - Groyne C36. Typical pattern consistent with gribble attack showing galleries just below the surface that are eroded away by wave action. Striking the surface of the plank shows the galleries are shallow (indicated). The visual assessment rating for this plank (**Table 5.1**) was '2', although the image focusses on a small part of the plank.

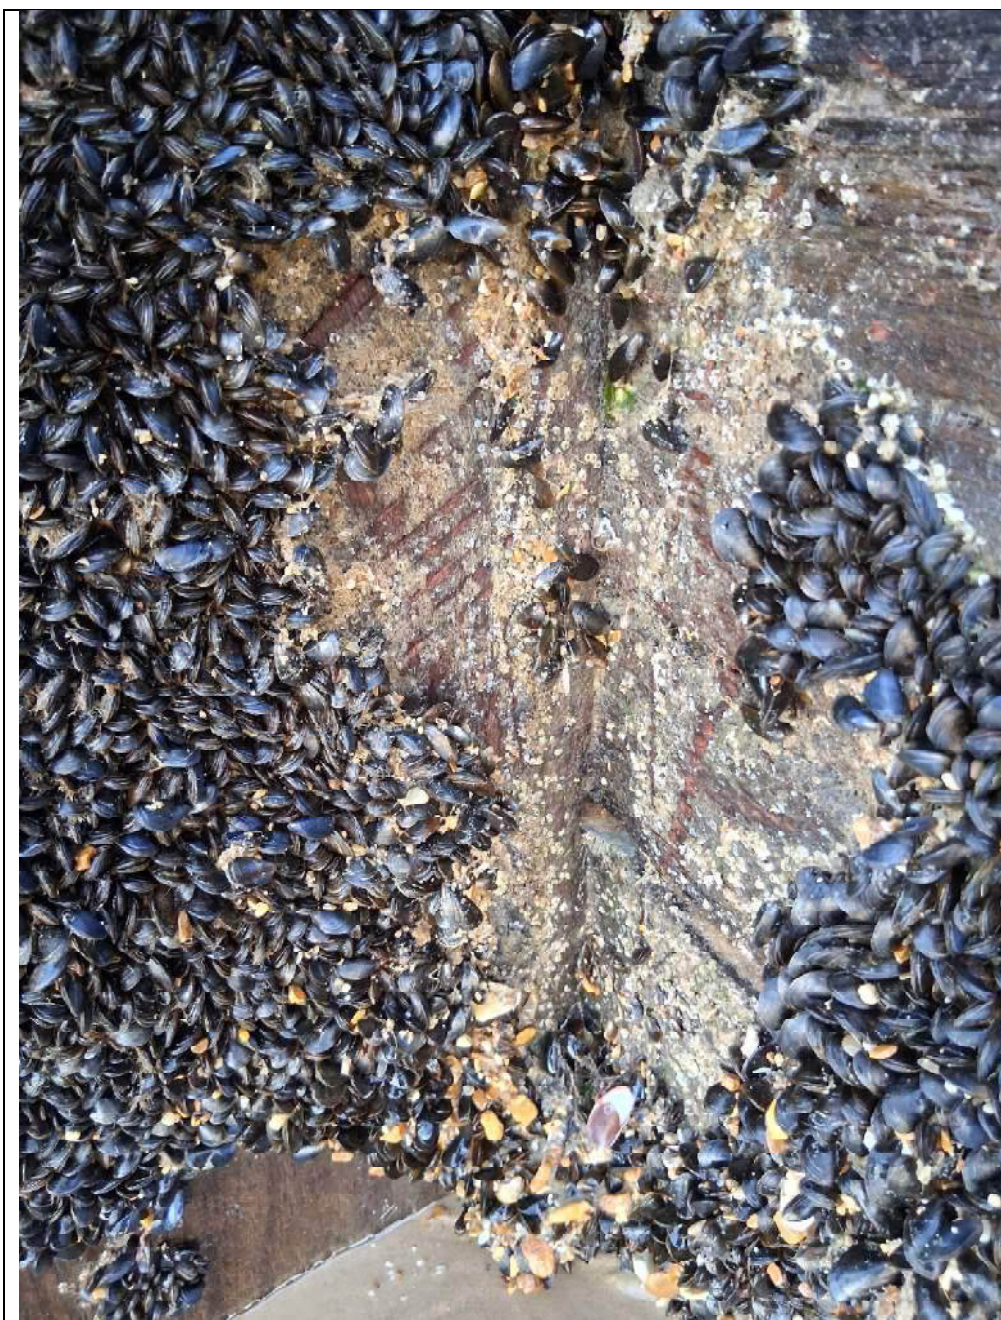
Minor erosion affected piles 1 (**Plate 7**), 2 (**Plate 10**) 3, 4 and 6, although considerably more erosion was observed on pile No 5 (**Plates 13 and 15**). Erosion estimates are presented in **Table 6.1**.

**Plate 7** - Groyne 36. Scraping away of marine fouling to expose the connection between the king pile (Pile 1) and adjacent planking on the more sheltered landward face of the pile where gribble colonisation is most likely in the intertidal zone. In this location, there was no sign of gribble attack, no damage was observed and the visual assessment rating is '0' (**Table 5.1**).

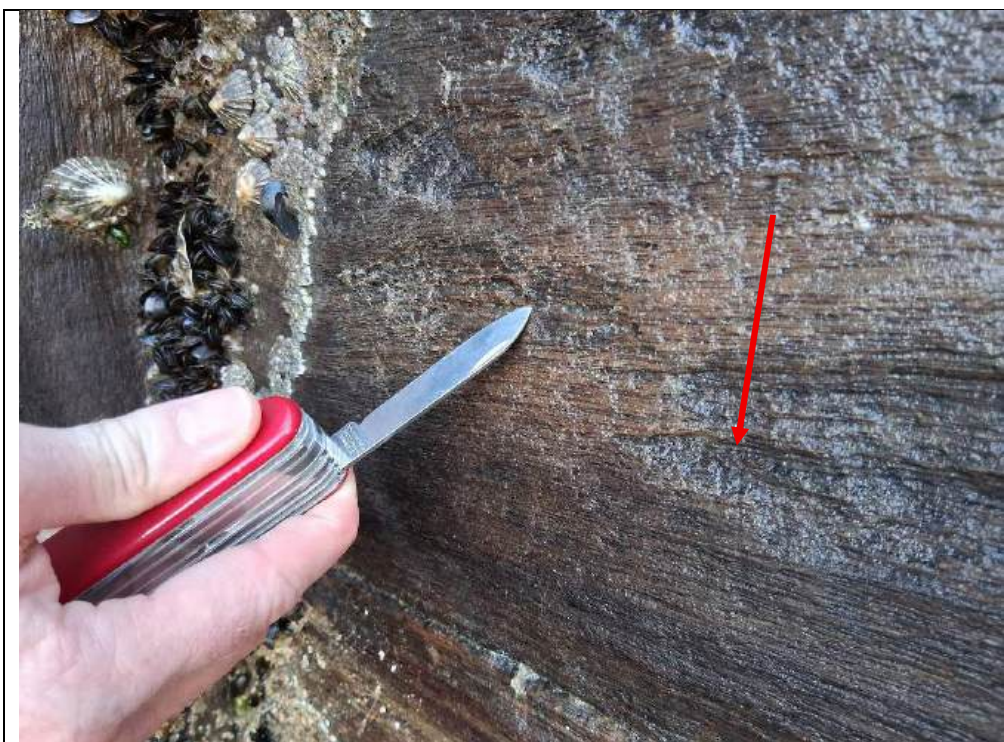
**Plate 8** - Groyne C36. Erosion of the face of a plank in the intertidal zone. The plank has suffered some erosion as indicated by the knife. The arrow shows a combination of grazing behaviour and subsequent erosion. Visual assessment rating '2'.

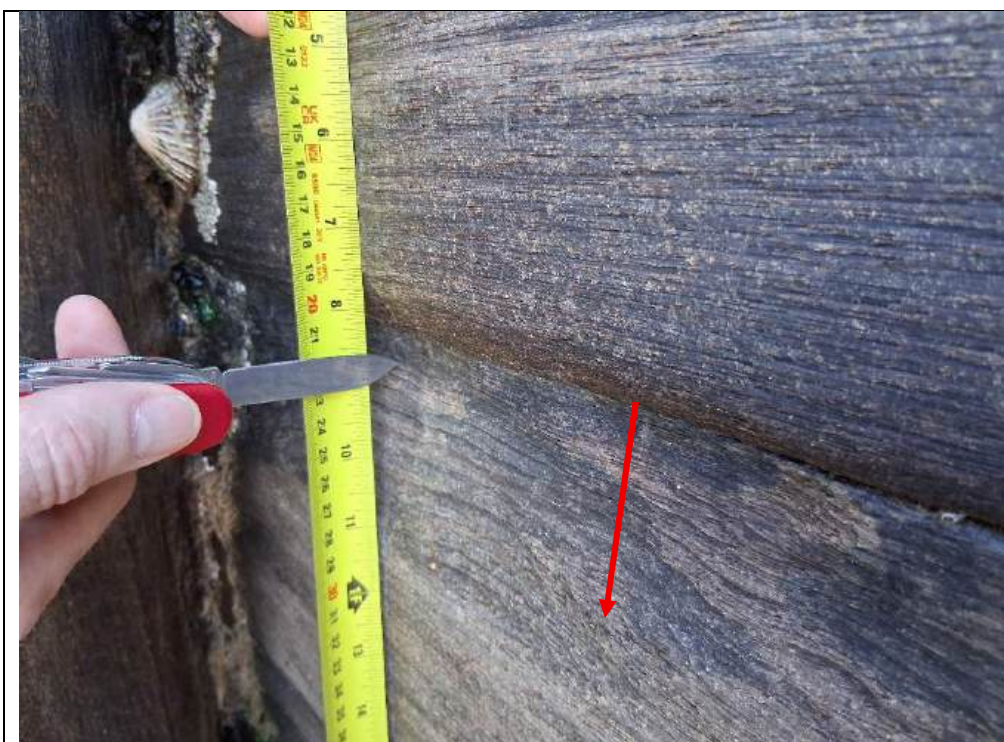
The groyne planks exhibited variable performance. After 10 years' service, there was a clear pattern of erosion that had caused 'scalloping' (**Plates 9, 13 and 17**) of the planks adjacent to the landward face of the piles at the seaward end of groyne C36 (piles 1 to 10). The extent of scalloping of the planks varied and was not measured.

**Plate 9** - Groyne C36. Typical 'scalloped' appearance of a plank caused by backwash of sediment as indicated by the knife. The faint pitted appearance (indicated) suggests erosion has exposed and eroded gribble galleries. The visual assessment rating is '2'.

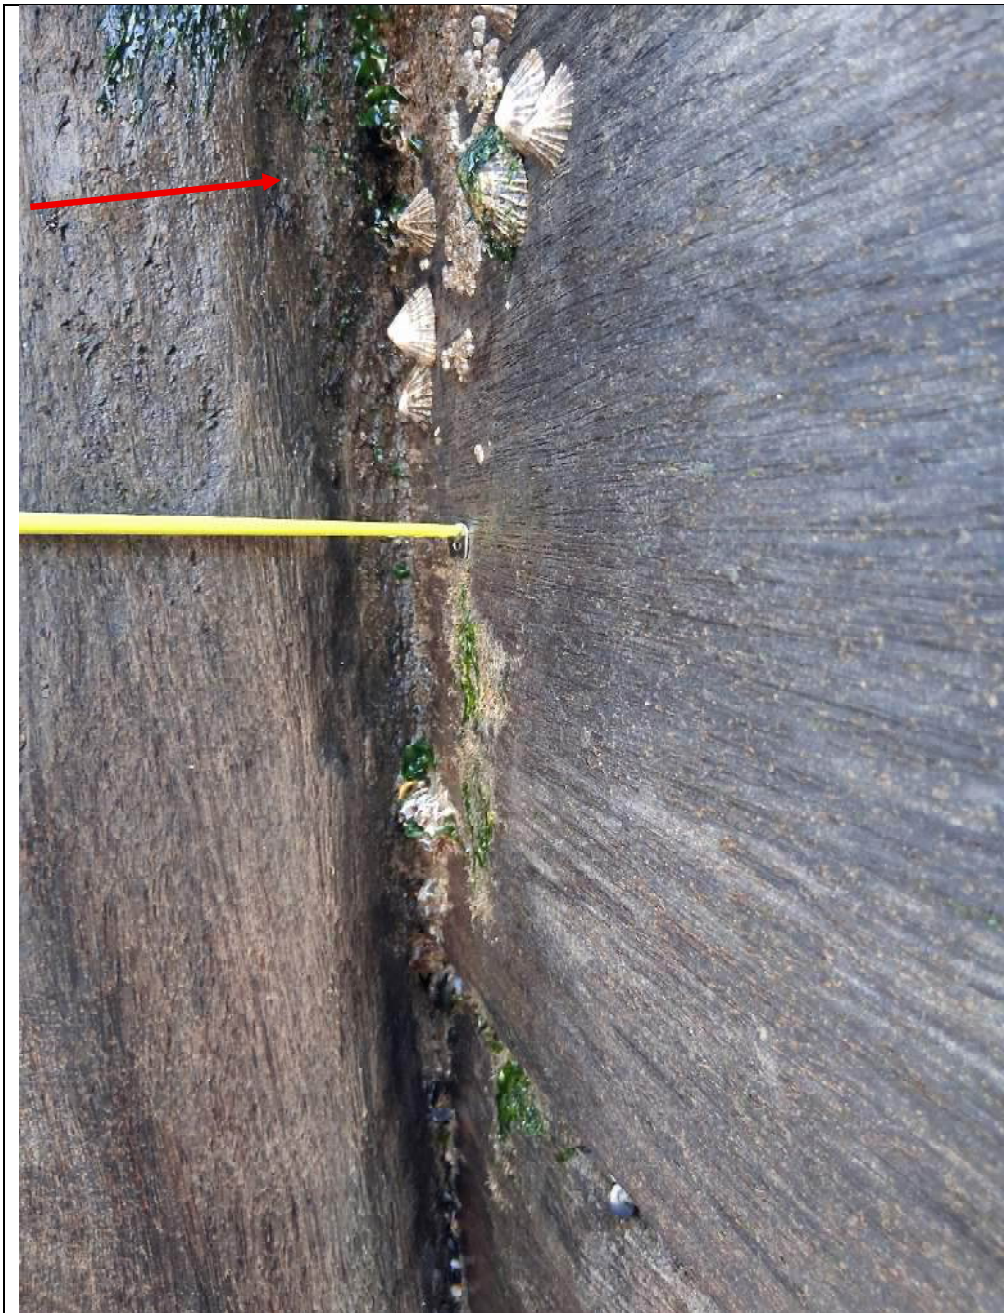
**Plate 10** - Groyne C36. An example of erosion observed on the landward face of pile 2 caused by backwash of sediment abrading the pile surface. This action can create refugia for gribble, which can then attack the timber as just discernible at the eroded pile edge (indicated) that has exposed galleries. The visual assessment rating is '1'.

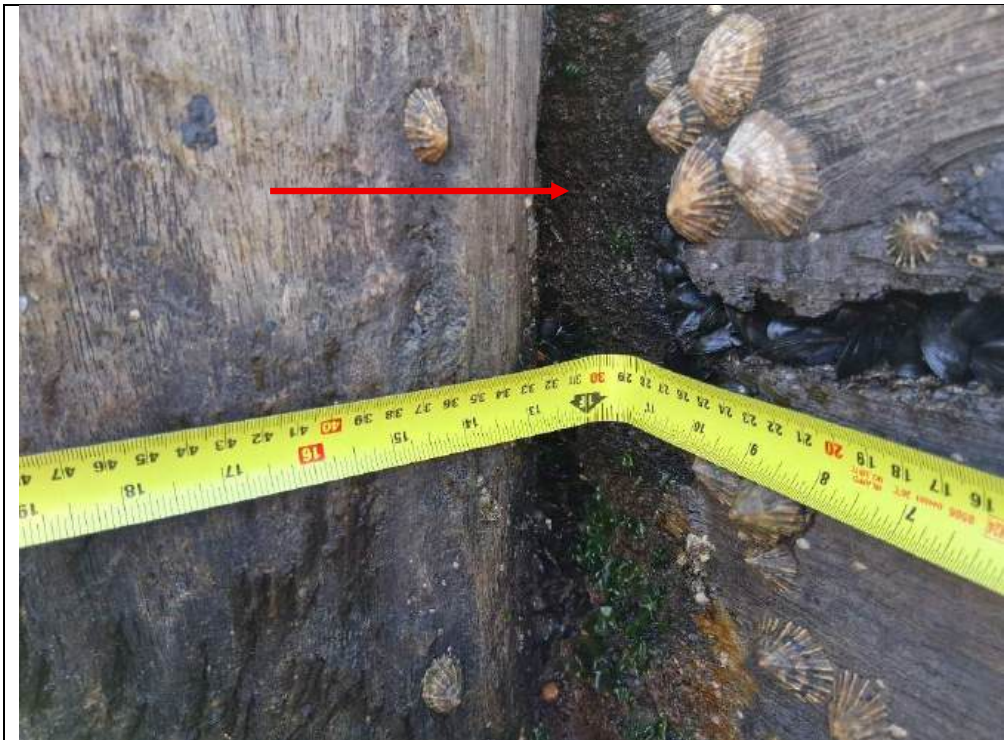
**Plate 11** - Groyne C36. An example of erosion observed on the landward face of a pile caused by backwash of sediment abrading the pile surface. This action can create refugia for gribble, which in this case (indicated) has colonised a sheltered part of the groyne and started to attack the plank. The visual assessment rating is '3'.

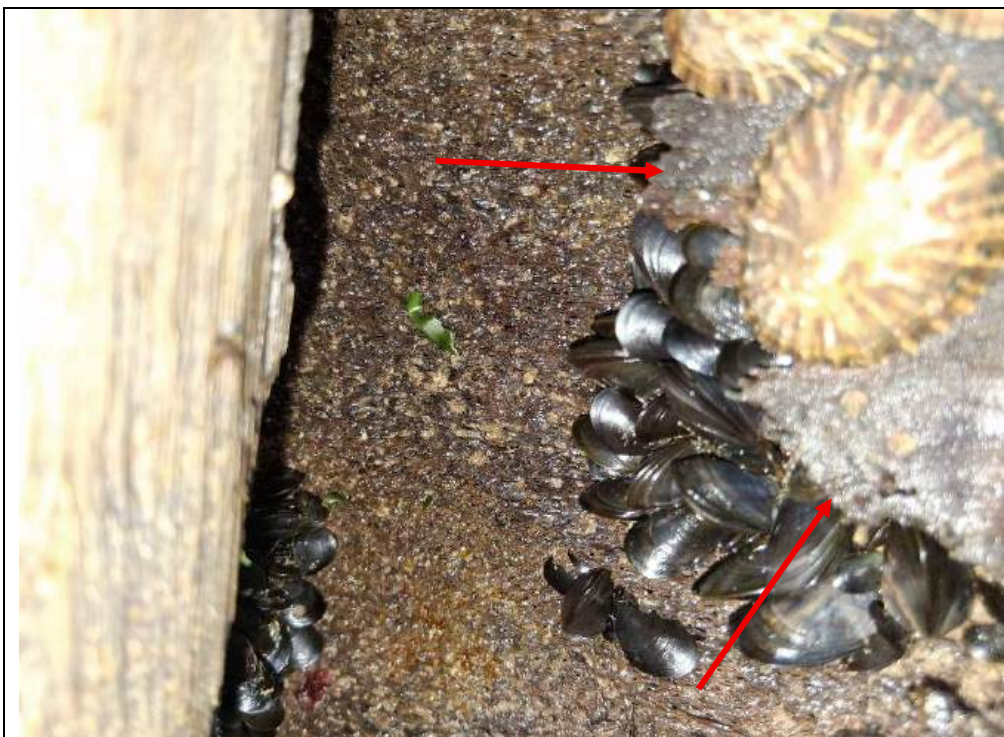
**Plate 12** - Groyne C36. An close-up image of gribble attack showing the typical appearance of the exposed galleries at the boundary of the surface of the plank and the 'gribble zone' (indicated). The visual assessment rating is '3'.

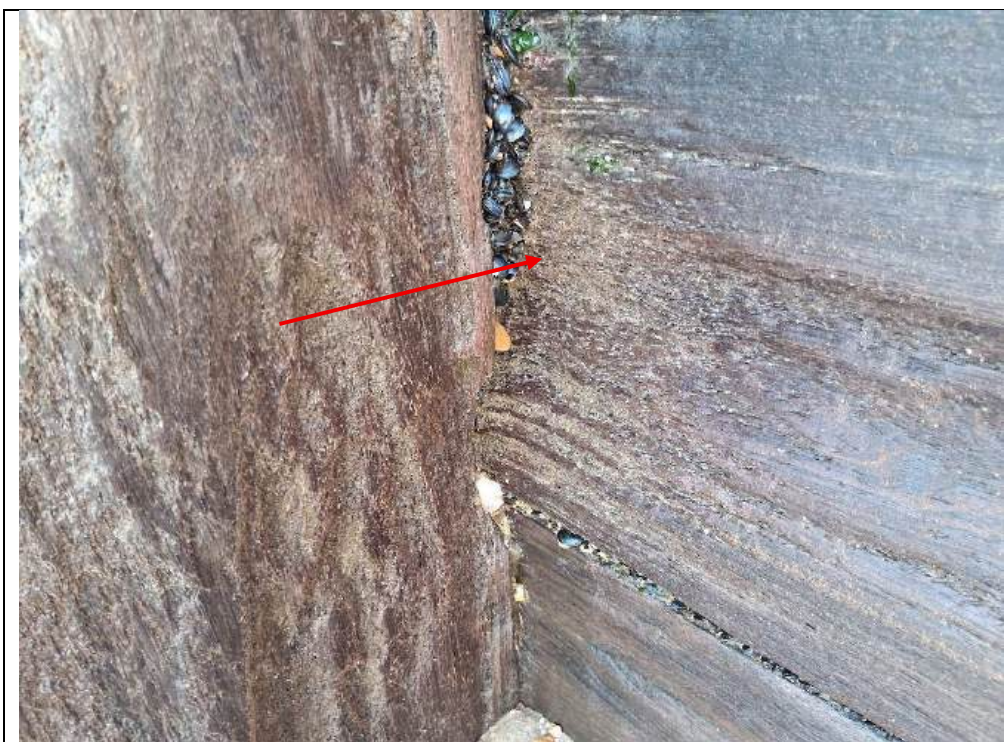
**Plate 13** - Groyne C36. General appearance of an eroded plank in the backwash zone where abrasion has exposed gribble galleries (indicated) and caused erosion of the surface of the pile. Although localised, the visual assessment rating for the plank is '2'. Also note the eroded surface of pile 5.

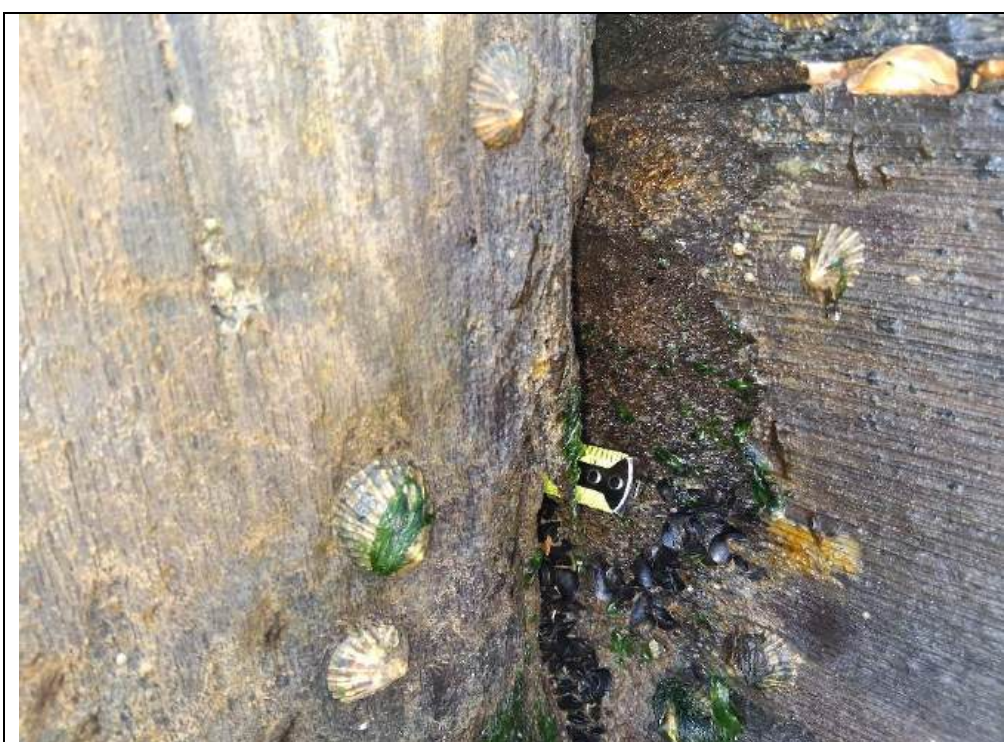
**Plate 14** - Groyne C36. A close-up image of gribble attack showing the typical appearance of the exposed galleries in the backwash zone adjacent to the landward face of pile 5. Note the extension of the measuring tape through a gap between the pile and plank indicating loss of section of both, caused predominantly by gribble attack and exacerbated by erosion. Although localised, the visual assessment rating for the plank is '3'.

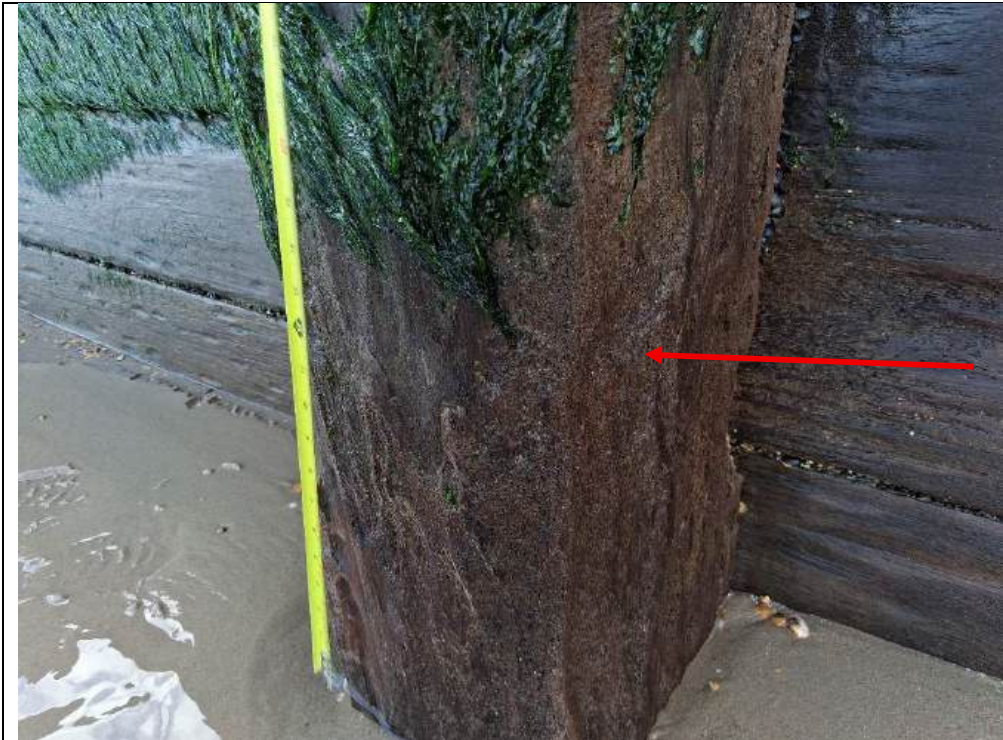
Although the piles identified in **Table 6.1** are in similar service conditions at the seaward end of the groyne, the substantial difference in performance of pile No. 5 indicates considerable variability in the performance of basralocus, which may be due to natural variation of the timber properties.

**Plate 15** - Groyne C36. Gribble attack and abrasion observed on pile 5 and the plank adjacent to the landward face of the pile (indicated). This image highlights the variable performance of basralocus in the intertidal zone. The general grazing pattern over the pile, particularly the landward face results in a visual assessment rating of '3'.

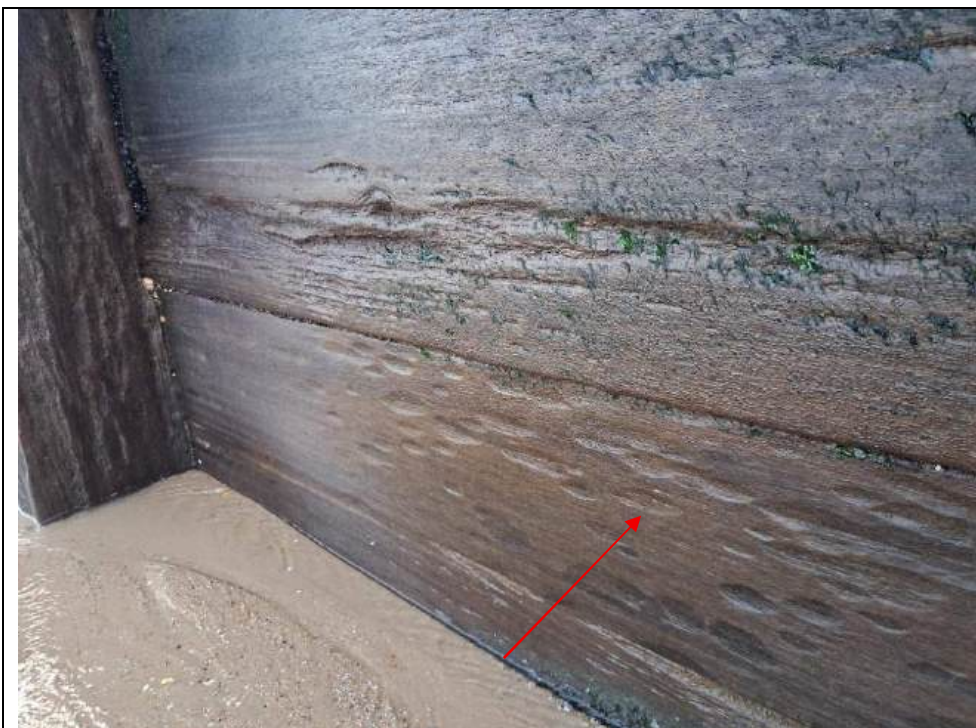
**Plate 16** - Groyne C36. A wider-angle view of **Plate 15** illustrating section loss caused by a combination of gribble attack and erosion (visual assessment rating '2') and an unusual pattern of erosion in the plank below (indicated), which has not been caused by gribble attack. This pattern may have been caused by erosion of pockets of lower density timber or of soft rot pockets. This image shows the variable nature of basralocus.

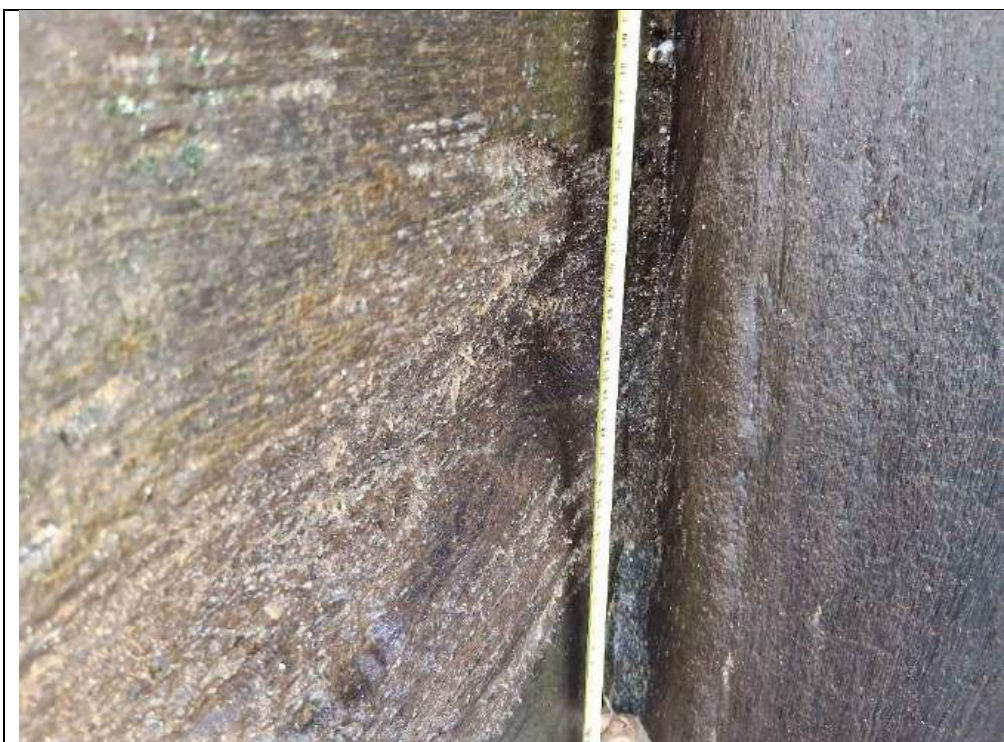
**Plate 17** - Groyne C36: Loss of section of a plank adjacent to the seaward face of a pile. This loss has been caused by a combination of gribble attack and subsequent erosion.

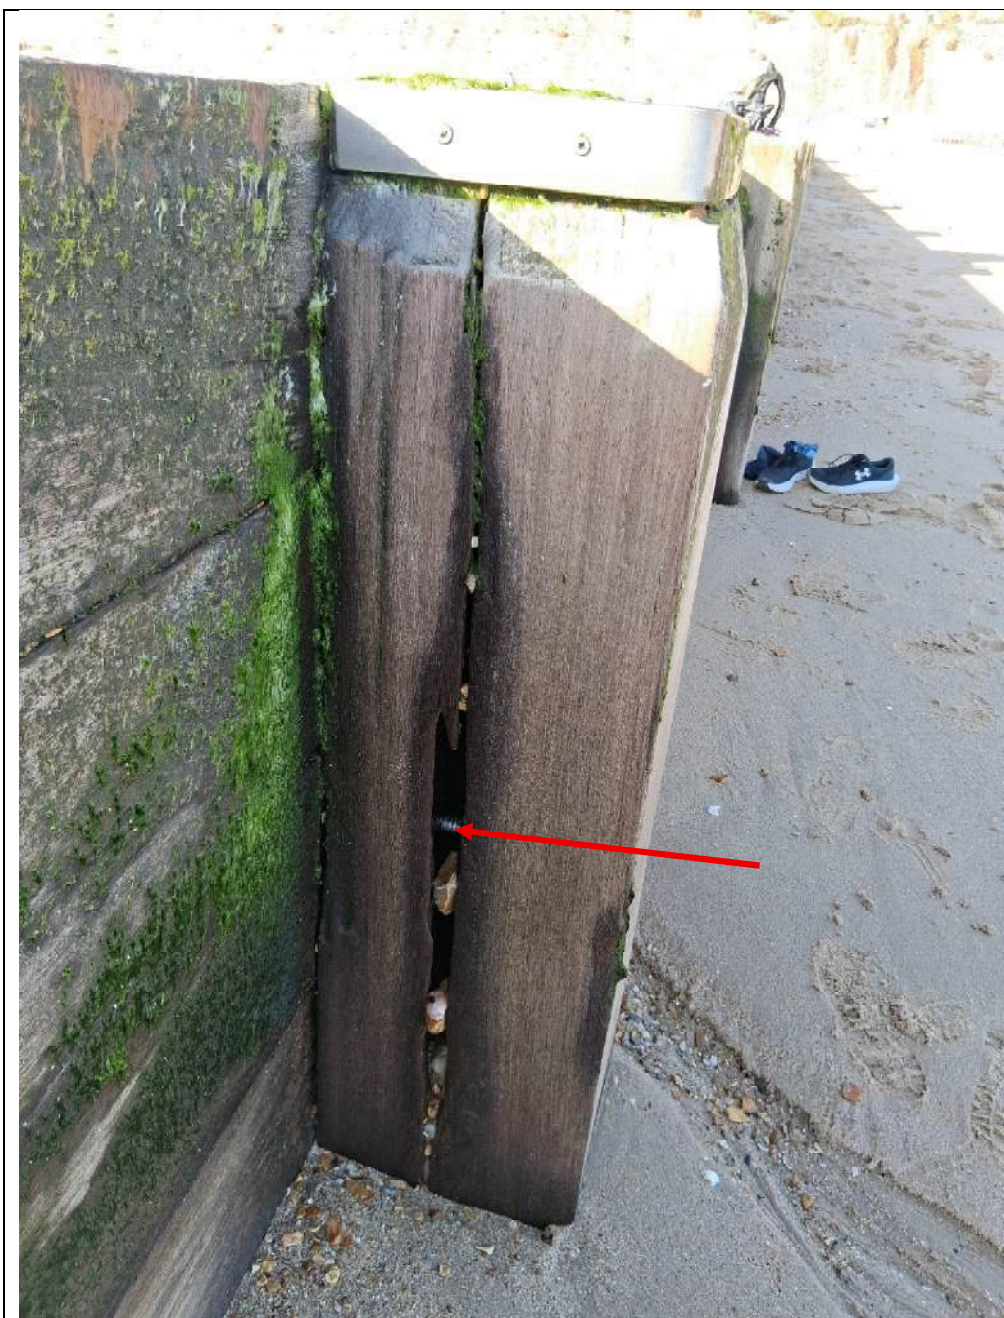
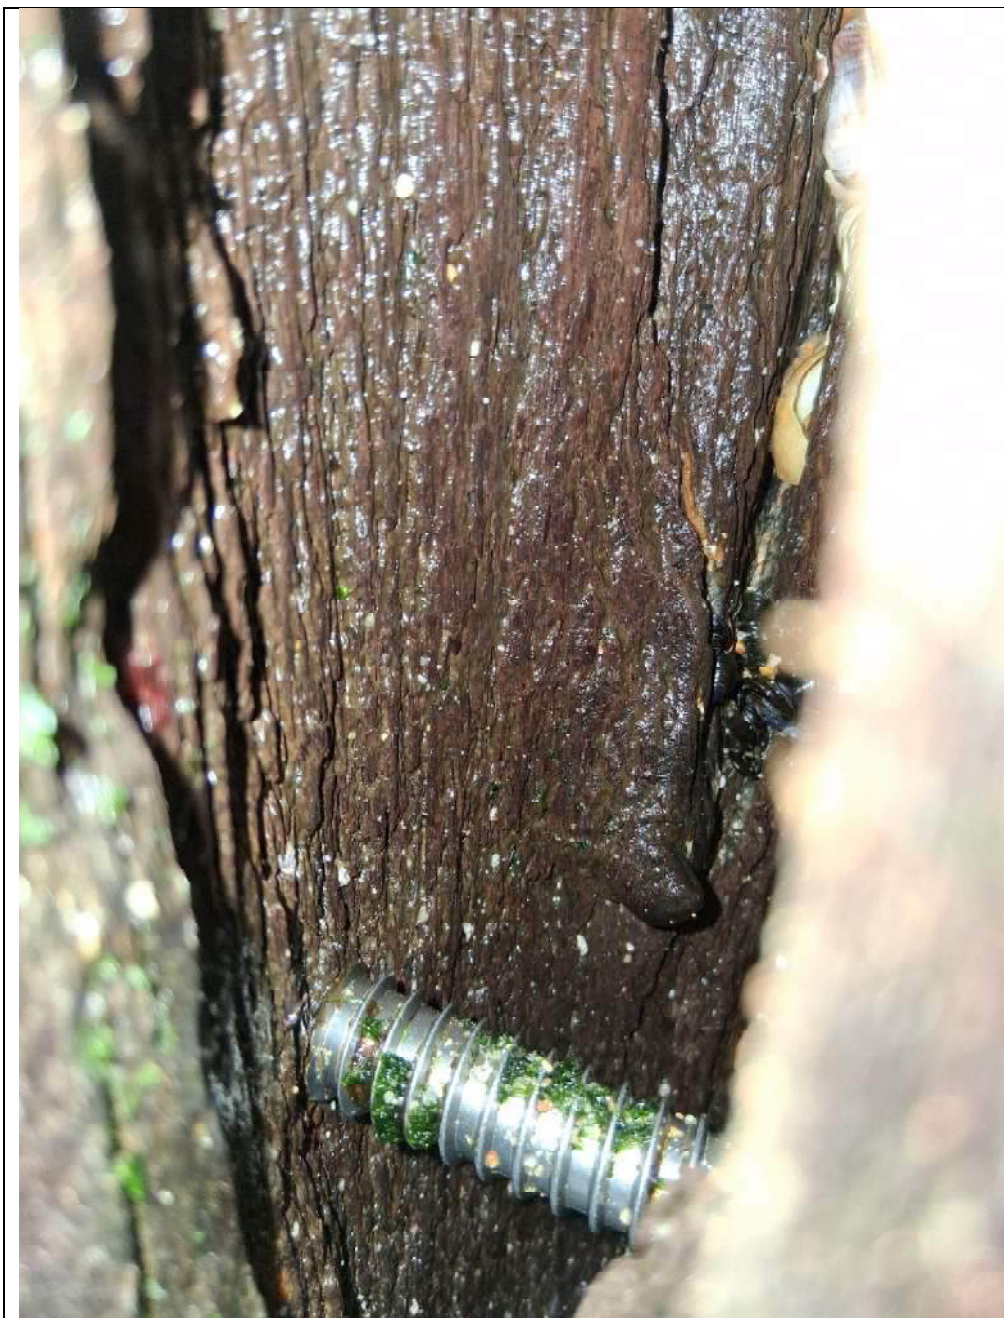
In one case, pile 9 had been 'hollowed out' by gribble attack (**Plates 18 and 19**) and its remaining service life may best be described as 'short', unlikely to last another 5 years and could possibly fail during a vigorous winter storm. The comparative poor performance of this pile was an outlying observation, but indicates that the marine borer resistance of basralocus in this case was highly variable.

**Plate 18** - Groyne C36. Pile 9. Substantial internal 'hollowing out' damage to a basralocus pile caused by gribble attack. This pile is at risk of failure; visual assessment rating '4'.

**Plate 19** - Groyne C36. Close up of the cavity of pile 9 shown in **Plate 18** illustrating the 'hollowing out' of the pile.

- It is unlikely that the piles at the seaward end of groyne C36 will deliver 15 years' service life, let alone the pile design life of 25 years.
- It is advisable to replace the seaward end of the groyne back to pile 10, and to replace with a combination of greenheart piles and ekki planking for maximum performance.

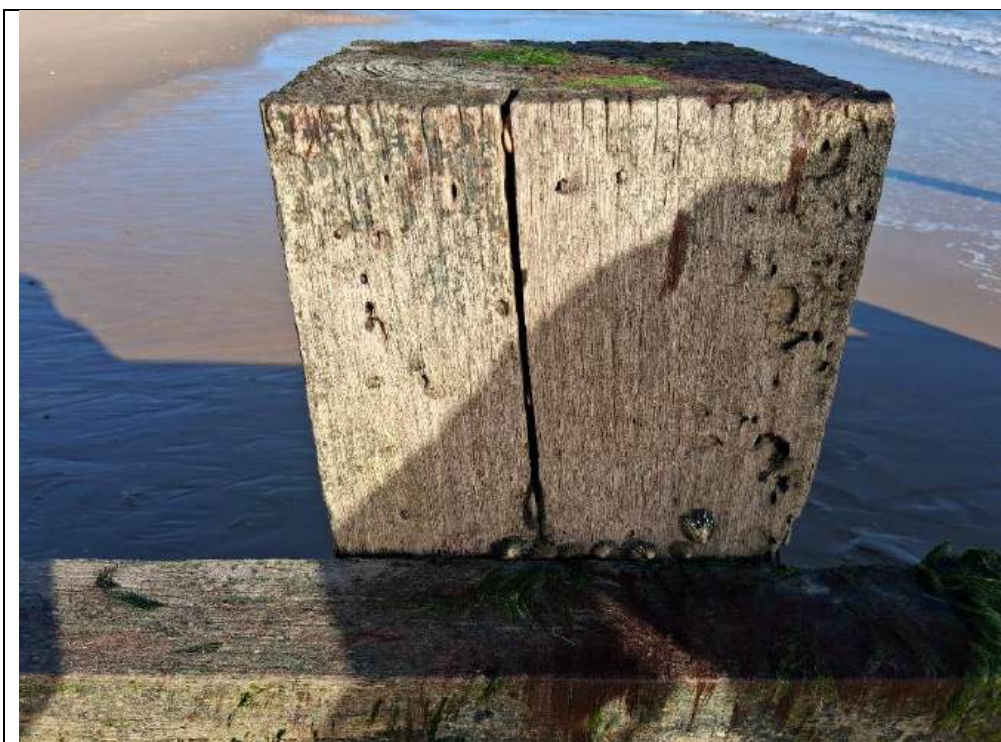
Damage associated with a timber borer was observed at the head of pile 5 (**Plate 20**). The elevation was too far above the mean height of the intertidal zone for it to be damage associated with shipworm. The most likely explanation is the activity of gammaridean amphipods, a sub-order of the *Crustacea* most probably exploiting previous holes made by a forest dwelling wood boring insect, possibly forest longhorn or scolytus beetle.

**Plate 20** - Groyne C36. Pitting observed at the head of pile 5 at the upper end of the intertidal zone. This is probably caused by a gammaridean amphipod, a sub-order of the *Crustacea*, exploiting previous holes made by a forest dwelling wood boring insect, possibly forest longhorn or scolytus beetle.

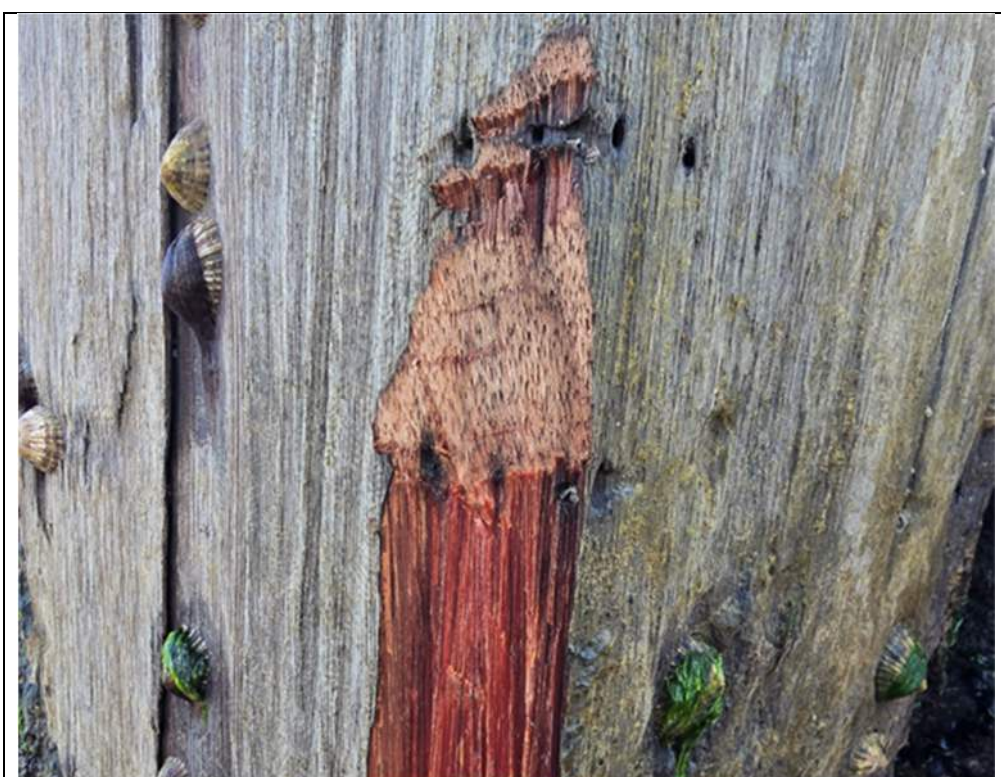
**Plate 21** - Groyne C36. Pitting observed on pile 5. The edge of the pile was removed to expose the tunnels.
