**BCP Council**

# Timber groynes

Evaluation of basralocus after 10 years in service

1286363-01 (00)

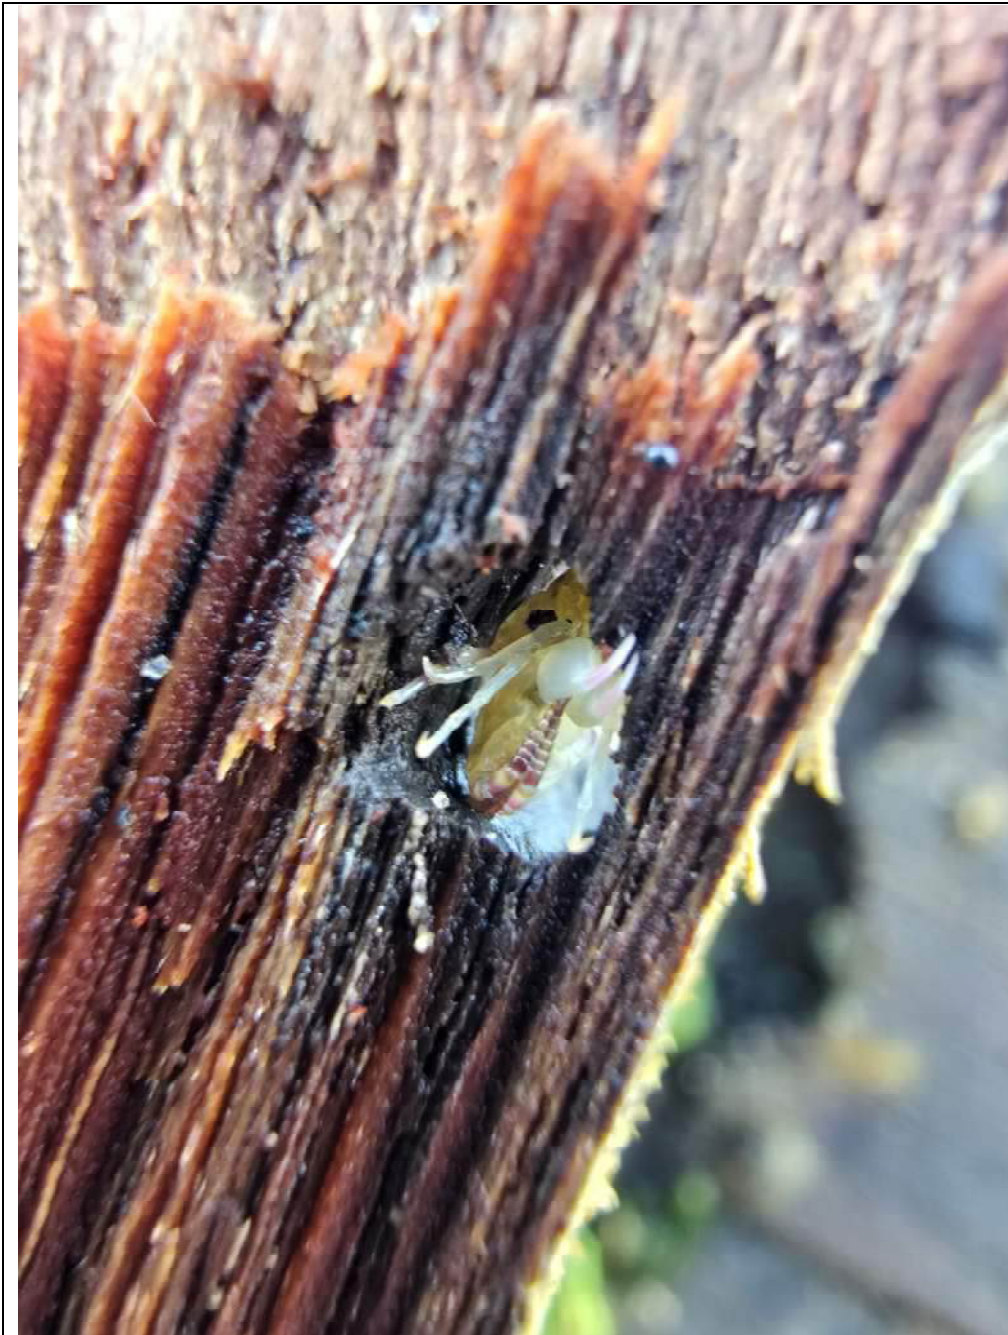
**Plate 22** - Groyne C36, pile 5. Breaking open the timber exposed an animal dwelling in the tunnel, most likely a gammaridean amphipod, a small shrimp-like crustacean.

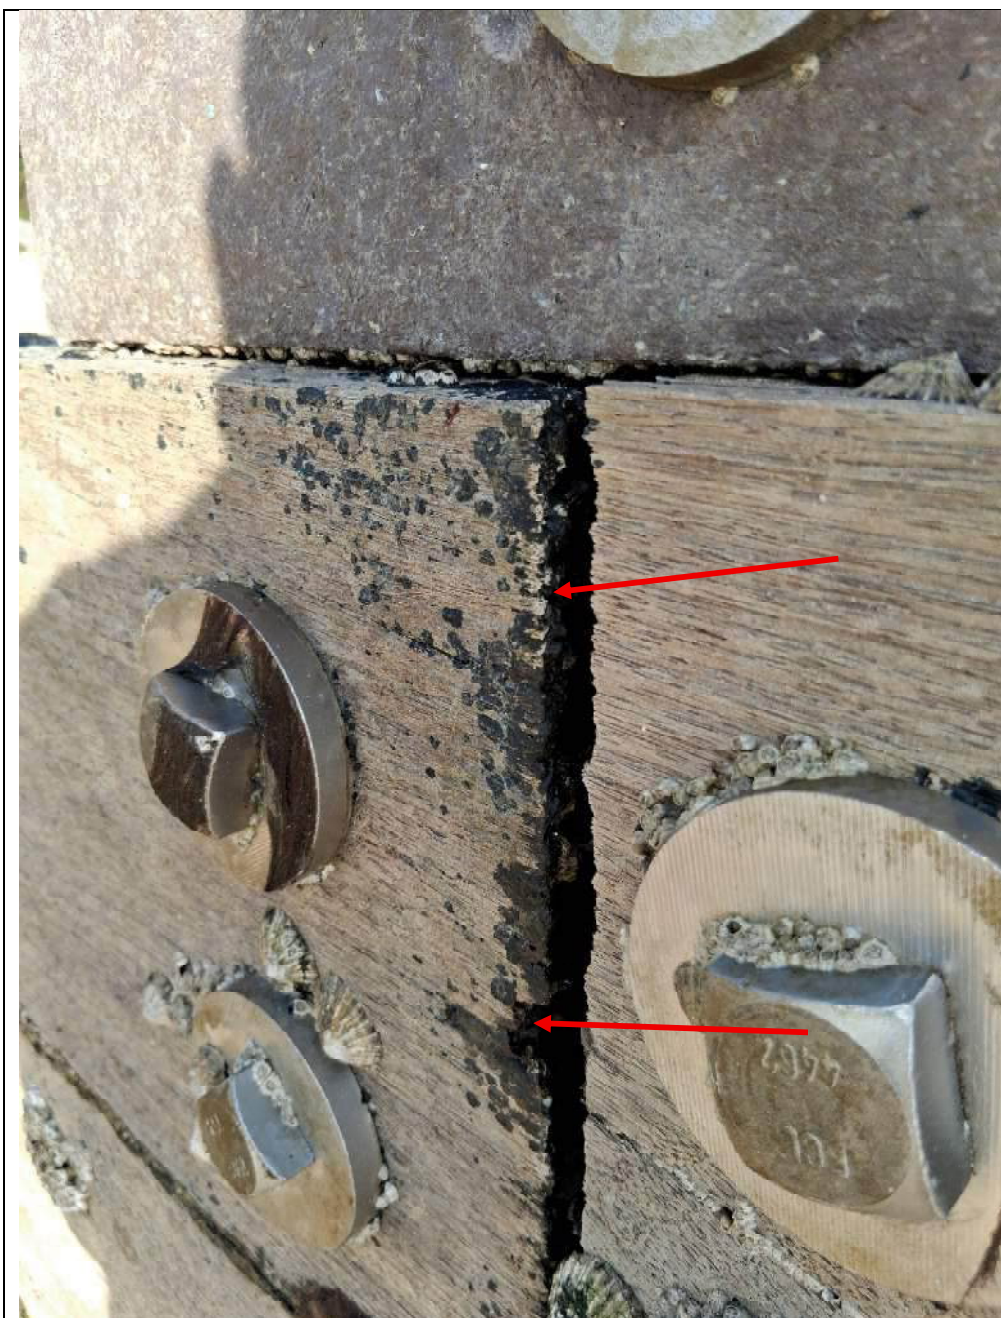
In some cases, the extent of damage could be seen at the end grains on the updrift faces of the planks. In the worst case locations, the loss of section was > 50%, which calls into question the remaining life expectancy of badly affected planks. These cases of severe damage were at the end grains of the planks (**Plates 12, 14 and 21**); however, these are the positions where the planks are fixed to the piles and failure would cause excessive stress to the remaining fixings at mid-length along the planks.

**Plate 23** - Groyne C36. Evidence of gribble damage to the end grain of adjacent planks (indicated) on the updrift face of the groyne where the planks are fixed to pile 5. Damage was typically seen on the more sheltered downdrift face. The loss of section within the plank results in a visual assessment rating of '4'.

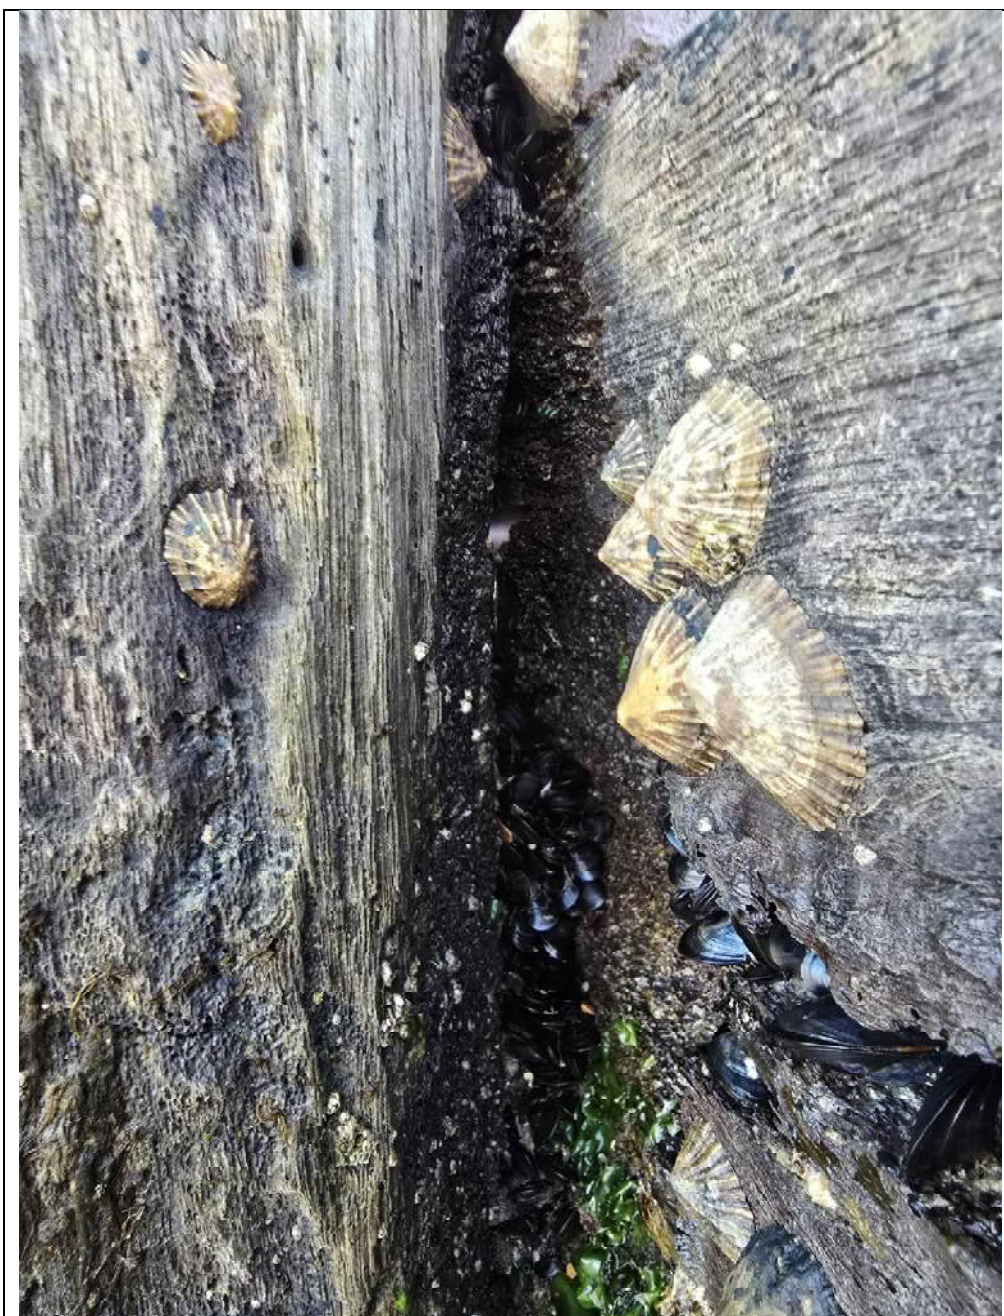
**Plate 24** - Groyne C36, pile 5 showing the damage to a plank on the downdrift elevation. The loss of section of the plank results in a visual assessment rating of '4'.

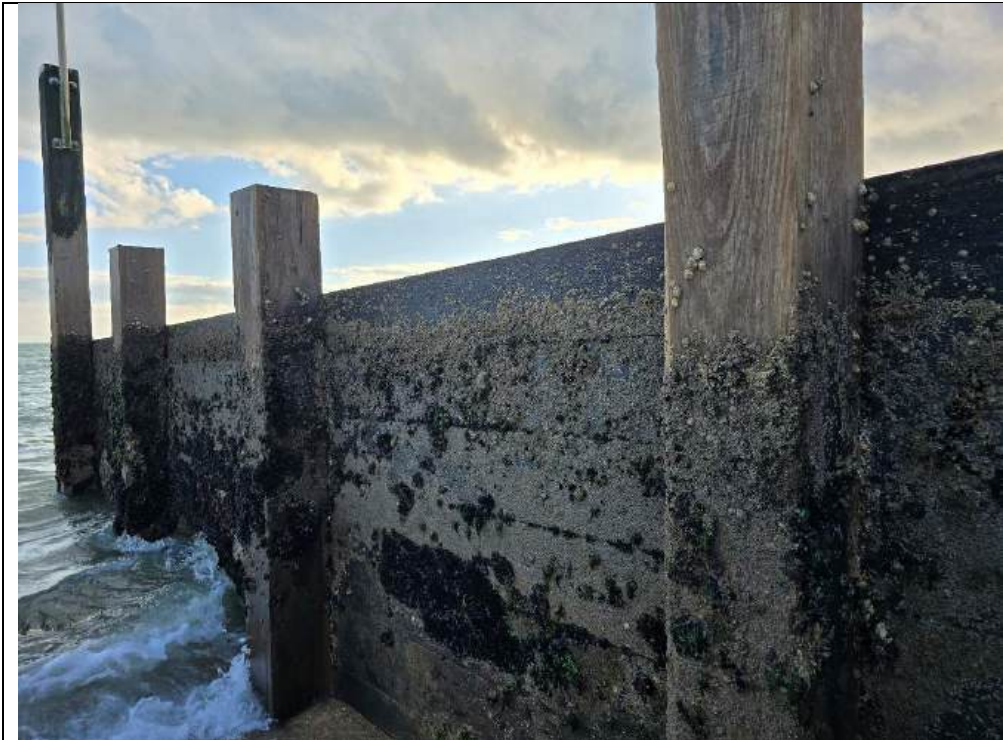
**Plate 25** - Groyne 37. Seaward end of the groyne showing piles 1 to 4. Note the contrast between the paler greenheart piles and darked ekki planks.

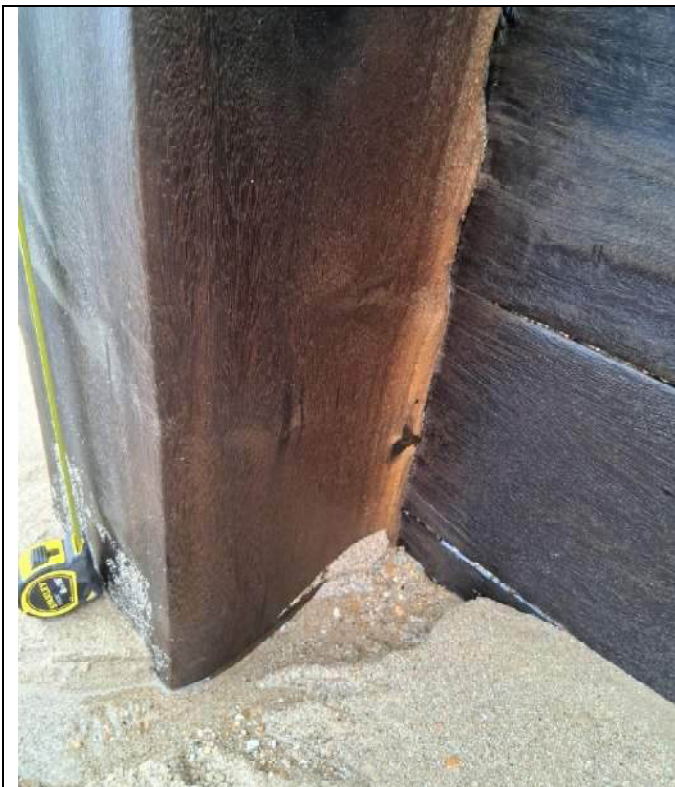
**Plate 26** - Groyne 37. Contrast between a greenheart pile and ekki planking. The pale edge of the greenheart coincident with the ekki planks appears to be slightly eroded and may be a sign of less durable sapwood that can be present on large cross section greenheart piles.

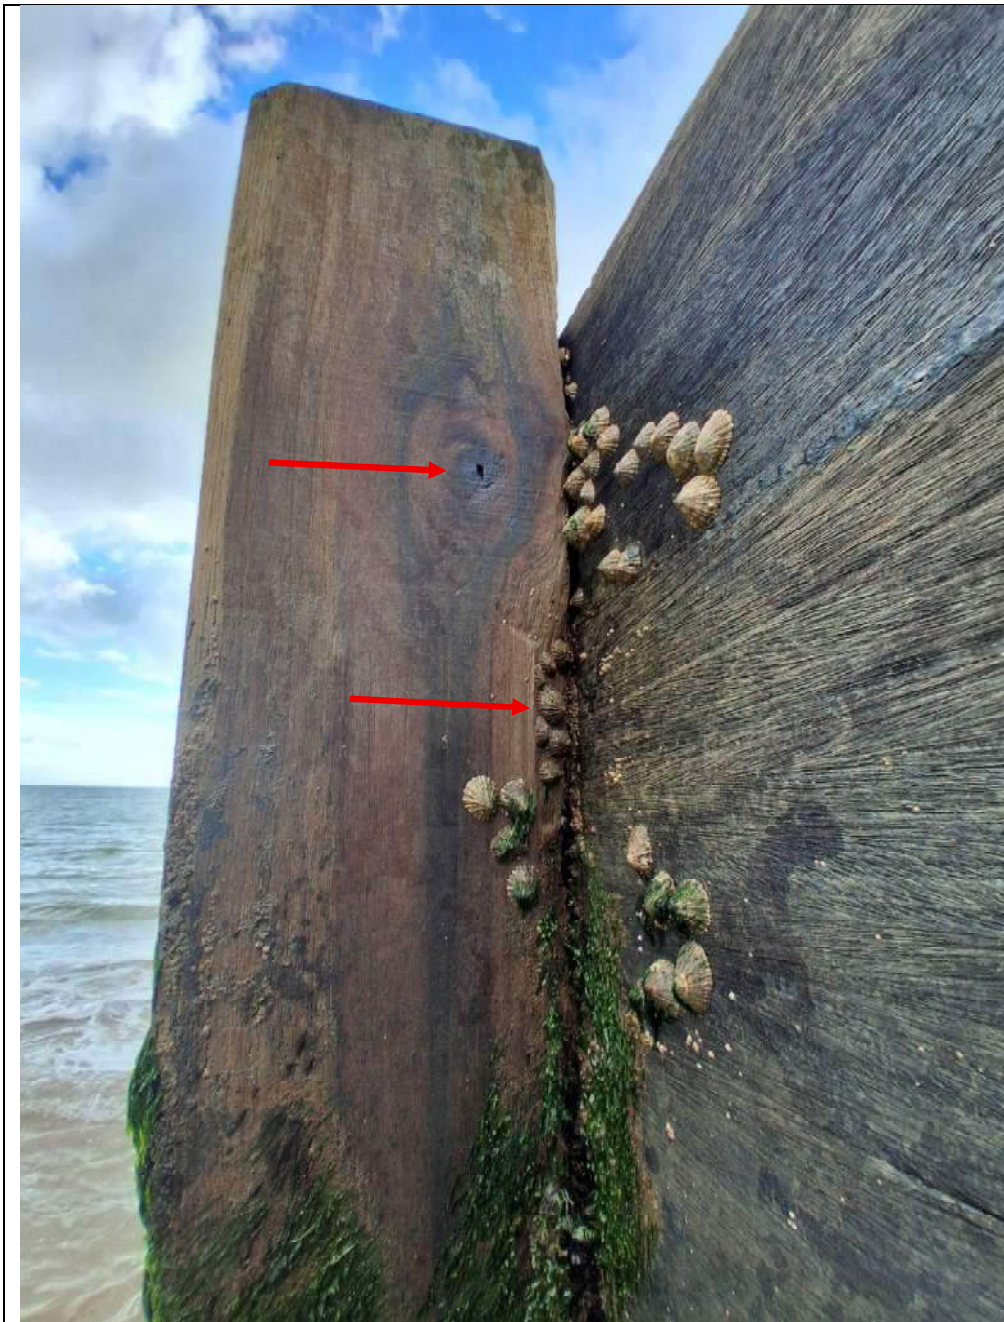
**Plate 27** - Groyne 37. Contrast between a greenheart pile and ekki planking. The pale edge of the greenheart coincident with the ekki planks appears to be slightly eroded and may be a sign of less durable sapwood which can be present on large cross section greenheart piles. The knot (indicated) in the darker heartwood causing distortion in the colouration of the pile reinforces the assertion that the paler wood comprises sapwood. There has been some erosion of the landward face as indicated by the barnacles lodged onto the timber (indicated).

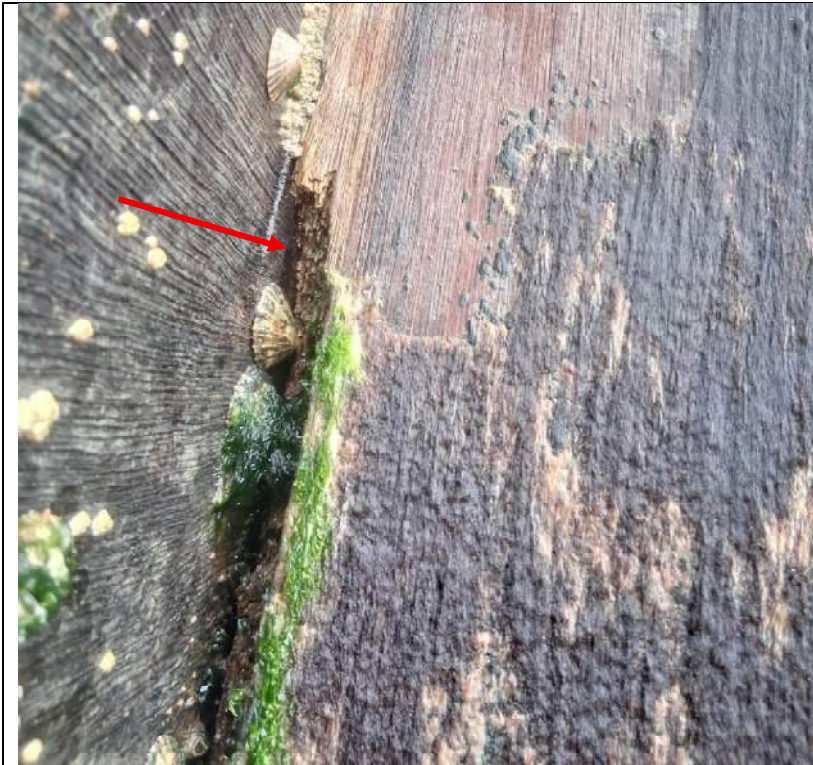
**Plate 28** - Groyne 37. Gribble attack at the edge of a greenheart pile on the seaward face. The damage is limited to the paler timber, which may be less resistant sapwood. The localised nature of the damage and minor loss of section at the edge of the pile results in a visual assessment rating of '2'.

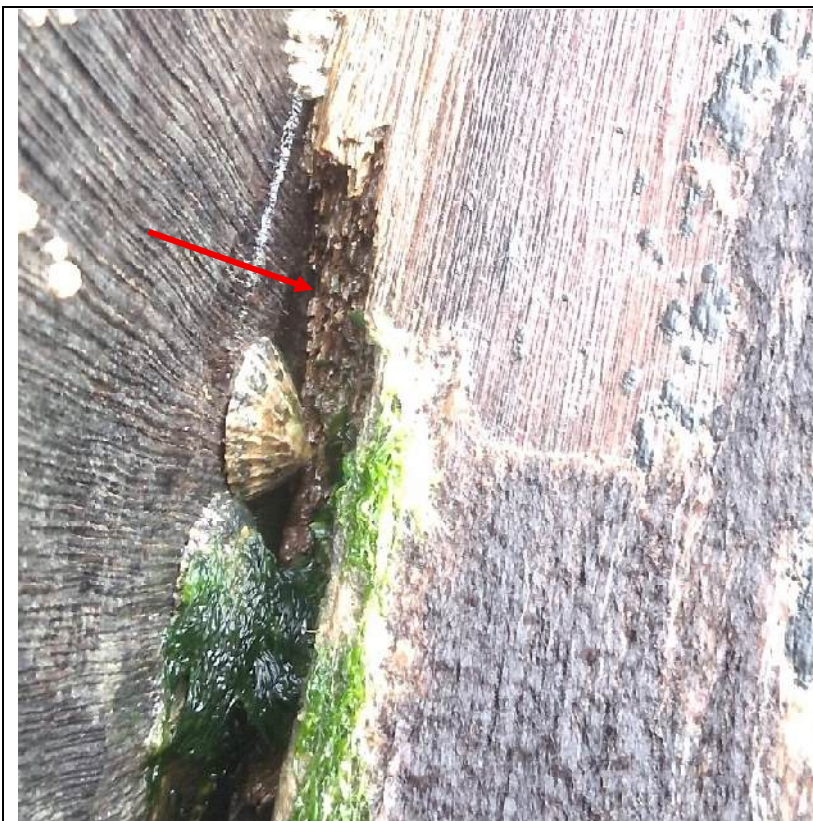
**Plate 29** - Groyne 37. A close-up image of **Plate 28** showing the gribble favouring to colonise and damage the greenheart (indicated) and not attacking the ekki.

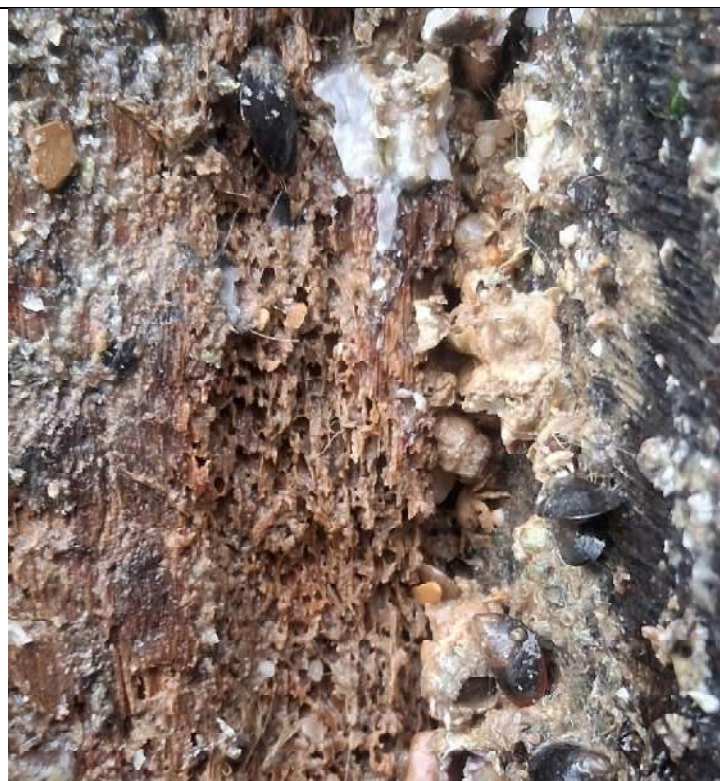
**Plate 30** - Groyne 37. Close-up image of gribble attack at the edge of a greenheart pile on the more sheltered landward face. Note the contrast between the greenheart and darker ekki, which has not been attacked by gribble. The localised damage and minor loss of section at the edge of the pile results in a visual assessment rating of '2'

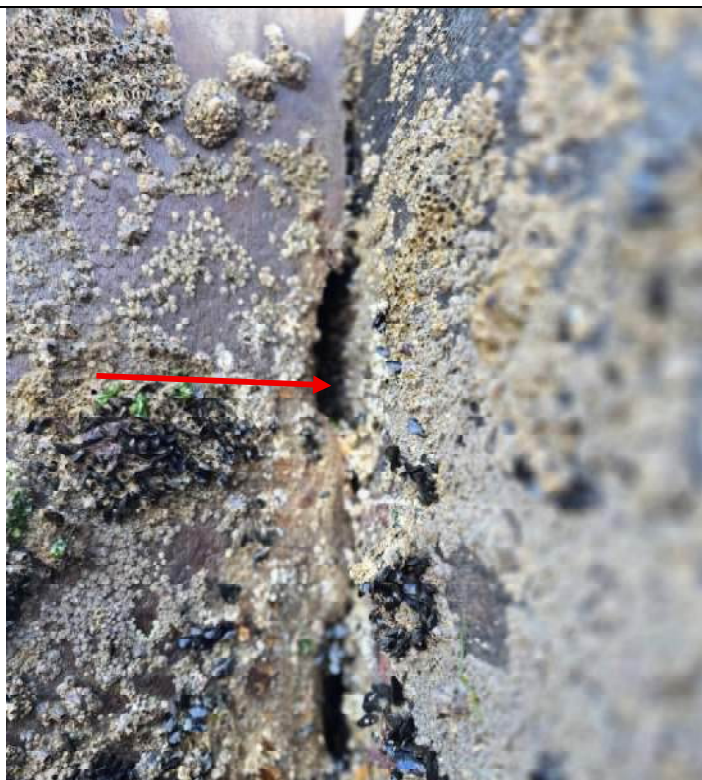
**Plate 31** - Groyne 37. Slight loss of section at the edge of pile 1 on the landward face (indicated) caused by gribble attack. There was no equivalent damage on the adjacent ekki planks. The localised nature of the damage and minor loss of section at the edge of the pile results in a visual assessment rating of '2'.

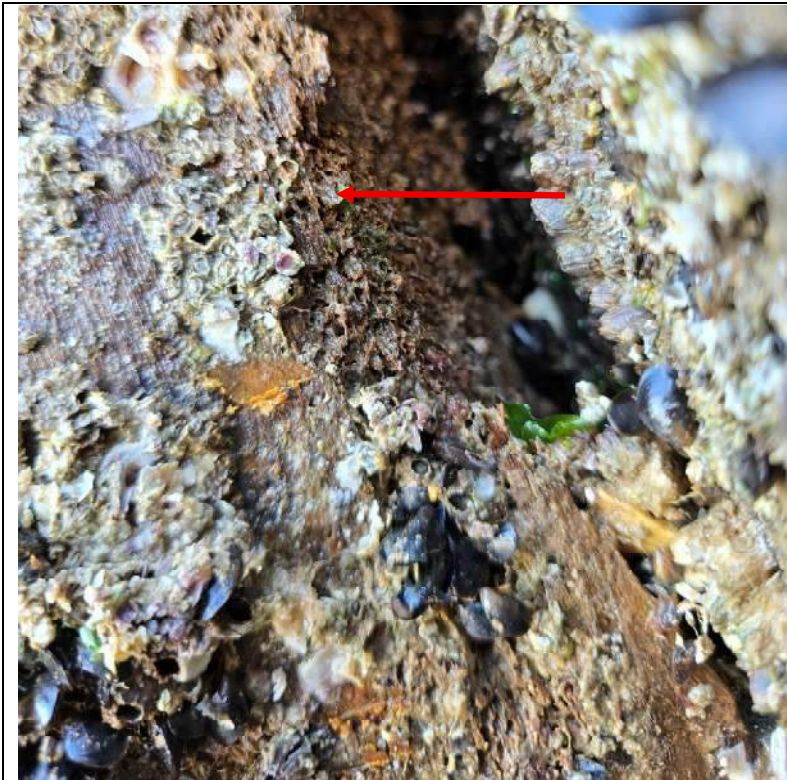
**Plate 32** - Groyne 37. Galleries characteristic of gribble attack on pile 1 (indicated).

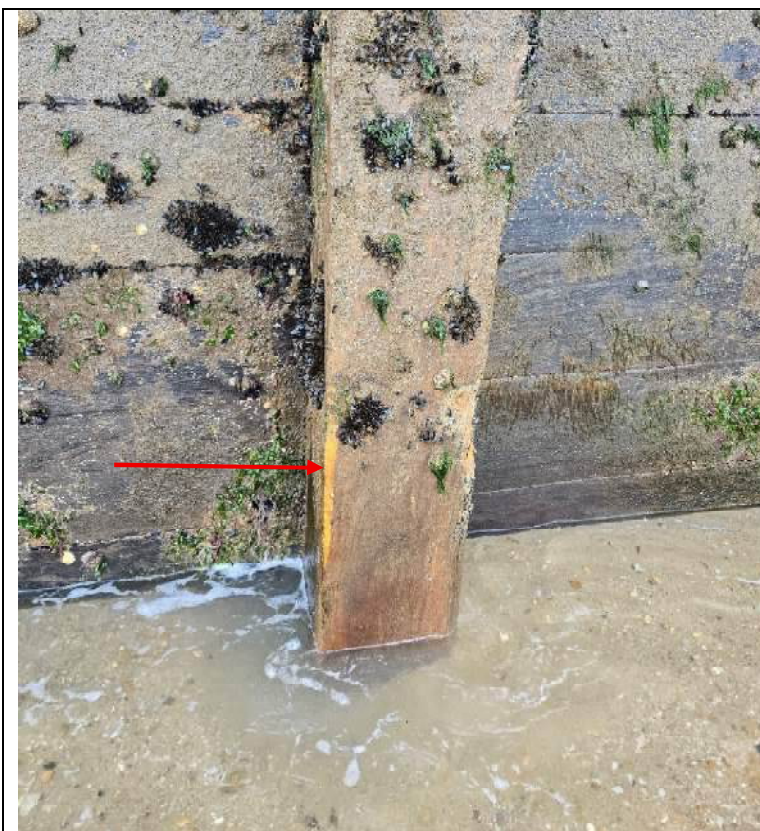
**Plate 33** - Groyne 37. An example of assessment for shipworm attack by removing the edge (indicated) of pile 4 to a length of ca. 500 mm in order to expose shipworm tunnels (photograph taken whilst work was in progress).

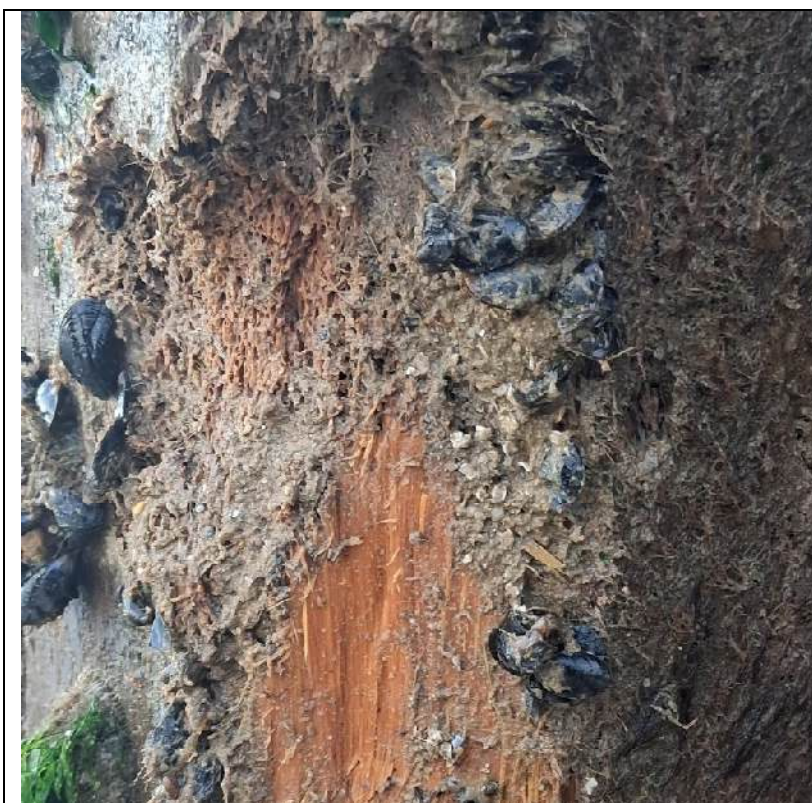
**Plate 34** - Groyne 37. Localised gribble attack on pile 4 has developed in part of the pile where there was section loss, possibly due to mechanical damage. Removal of the edge of the pile indicated that the gribble attack was limited to the surface. The localised nature of the damage and minor loss of section at the edge of the pile results in a visual assessment rating of '2'.

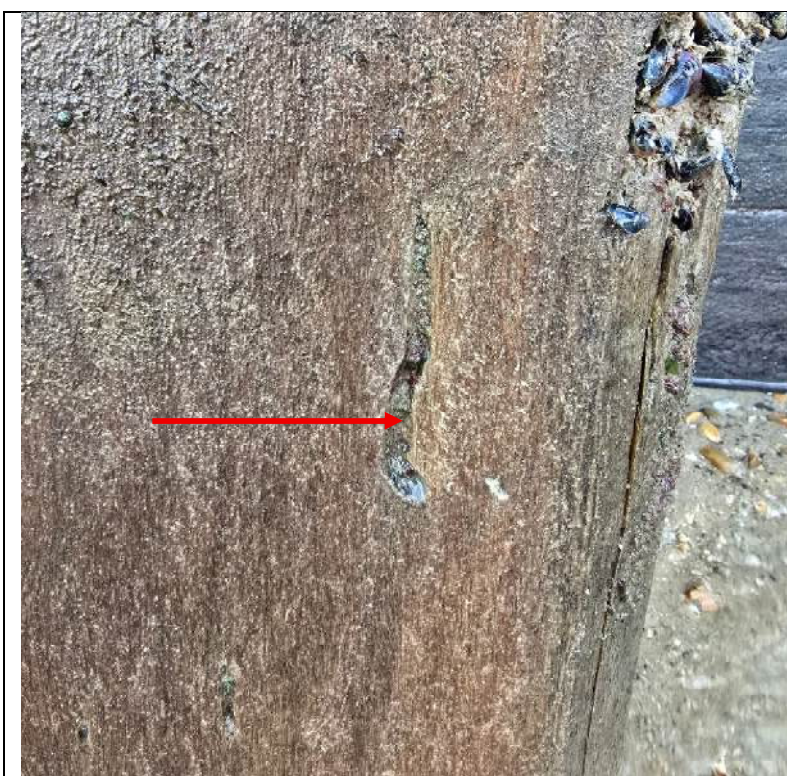
Gribble attack was observed between pile 1 (king pile) and pile 6. (**Plates 26, 27, 28 and 29**). No gribble attack was observed on the ekki planks. There was also evidence of shipworm colonisation on one pile (**Plates 35 to 38**) although this was very minor and unusual for the groyne field as shipworm is not a recognised hazard limiting groyne service life in the Bay.

**Plate 35** - Groyne 37. Shipworm tunnel exposed by abrasion of the surface of pile 4.

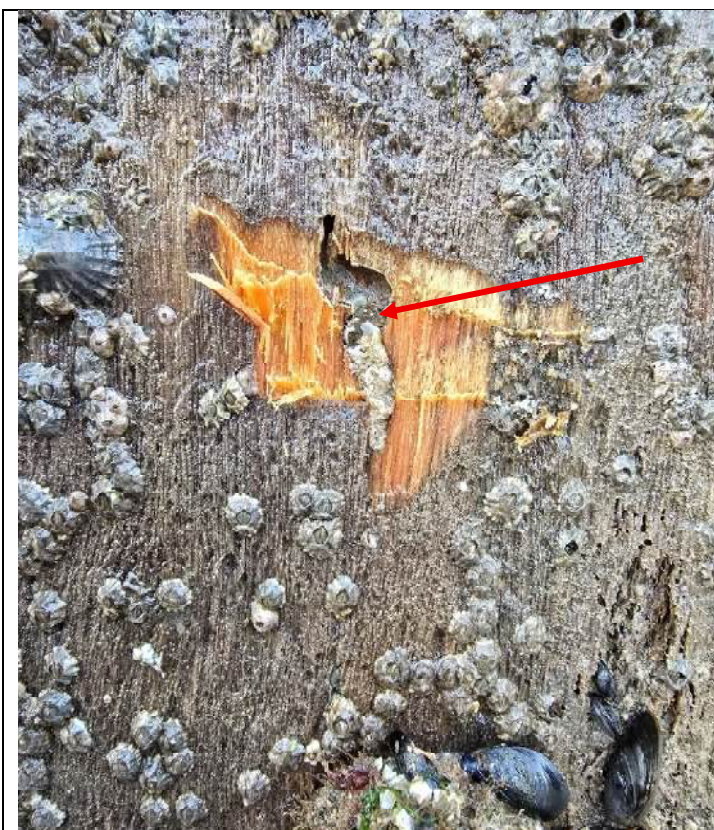
**Plate 36** - Groyne 37. Scraping away the surface layer of timber on pile 4 around a suspected shipworm siphon revealed the calcareous lined tunnel of a juvenile shipworm (indicated).

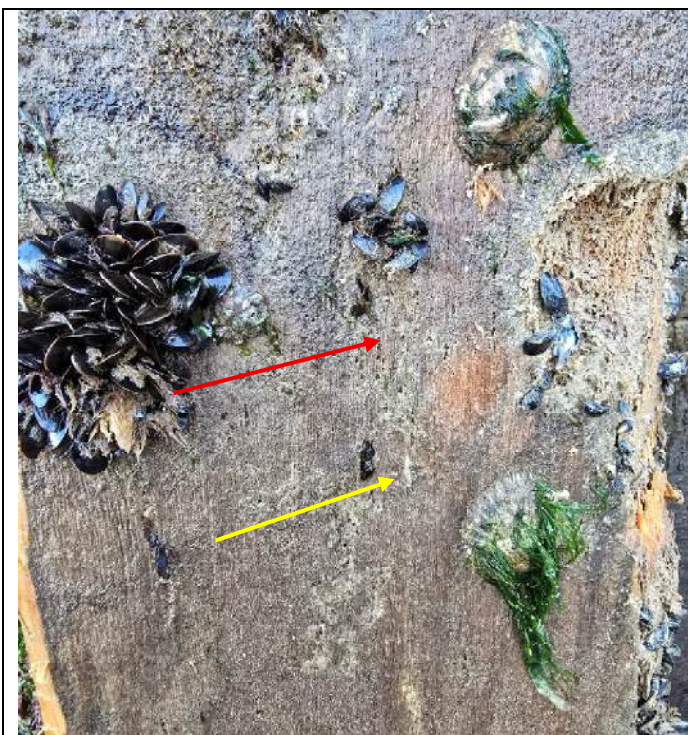
**Plate 37** - Groyne 37, pile 4. Suspected shipworm siphons (indicated) and the likely exposure of the calcareous lining of a shipworm tunnel (yellow arrow). The localised nature of the damage and minor loss of section at the edge of the pile results in a visual assessment rating of '2'.

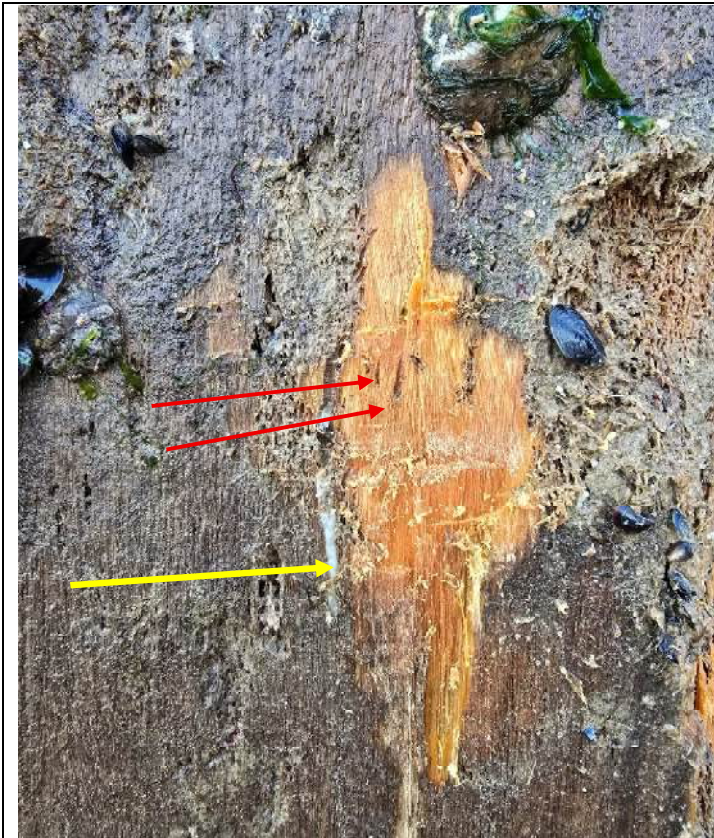
**Plate 38** - Groyne 37, pile 4. The yellow arrow indicates a shipworm tunnel. The red arrows indicate part-formed tunnels as a consequence of the larvae failing to lodge into the timber. The localised nature of the damage and minor loss of section at the edge of the pile results in a visual assessment rating of '2'.

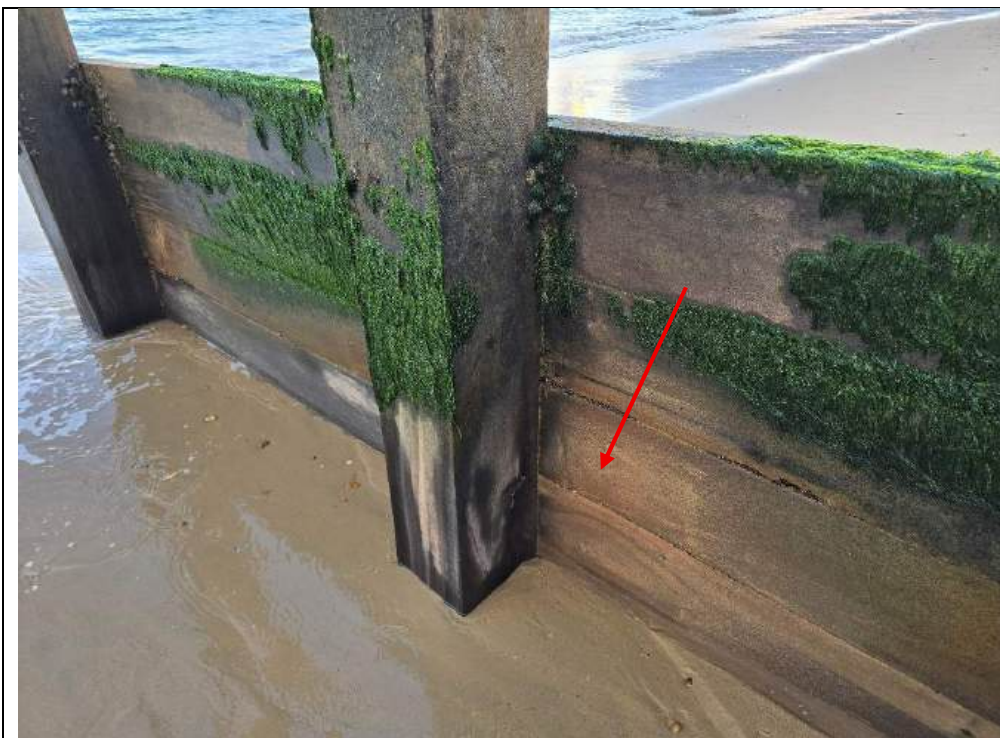
Groyne C30 was subject to a visual inspection only. Some erosion was observed at the edges of the piles 1 to 10 and some erosion of the planks visible as 'scalloping' caused by backwash of waves on the plank sections adjacent to the landward face of the piles. Gribble attack was observed at the edges of the planks and piles.

**Plate 39** - Groyne 30. General appearance of the greenheart piles and planks with some minor scalloping observed on the down-drift elevation (indicated).

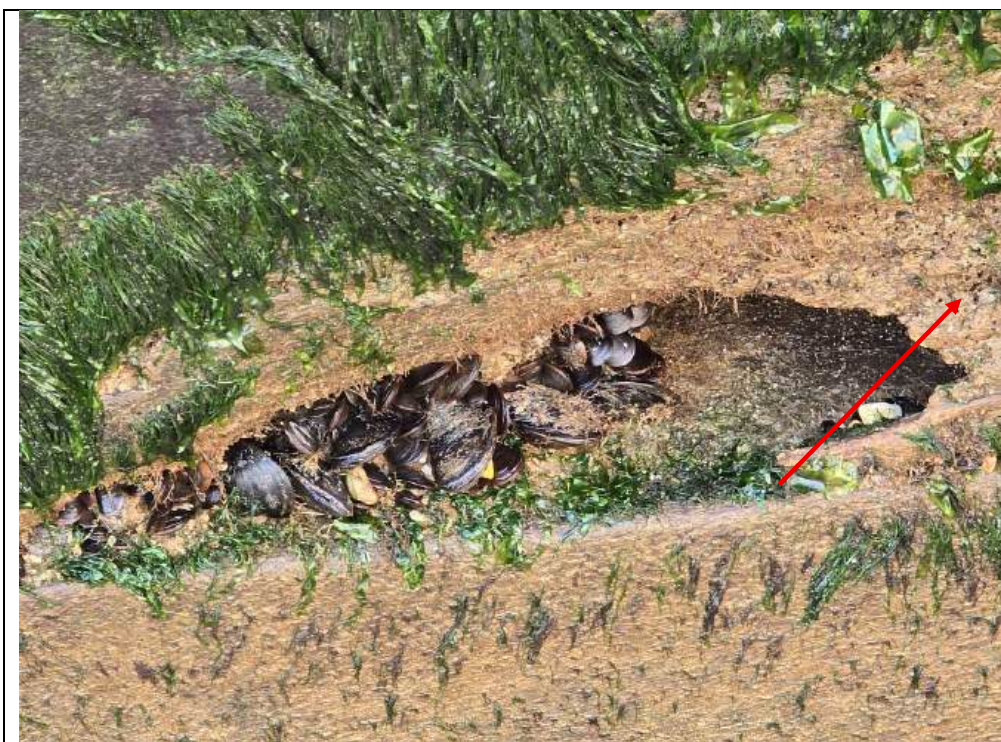
**Plate 40** - Groyne 30. Localised voiding of a plank. The most likely explanation is gribble attack of a softer part of a plank, which may have been caused by a pocket of incipient decay in the tree. Some gribble colonisation was observed (indicated). The localised nature of the damage and minor loss of section at the edge of the plank results in a visual assessment rating of '3'.

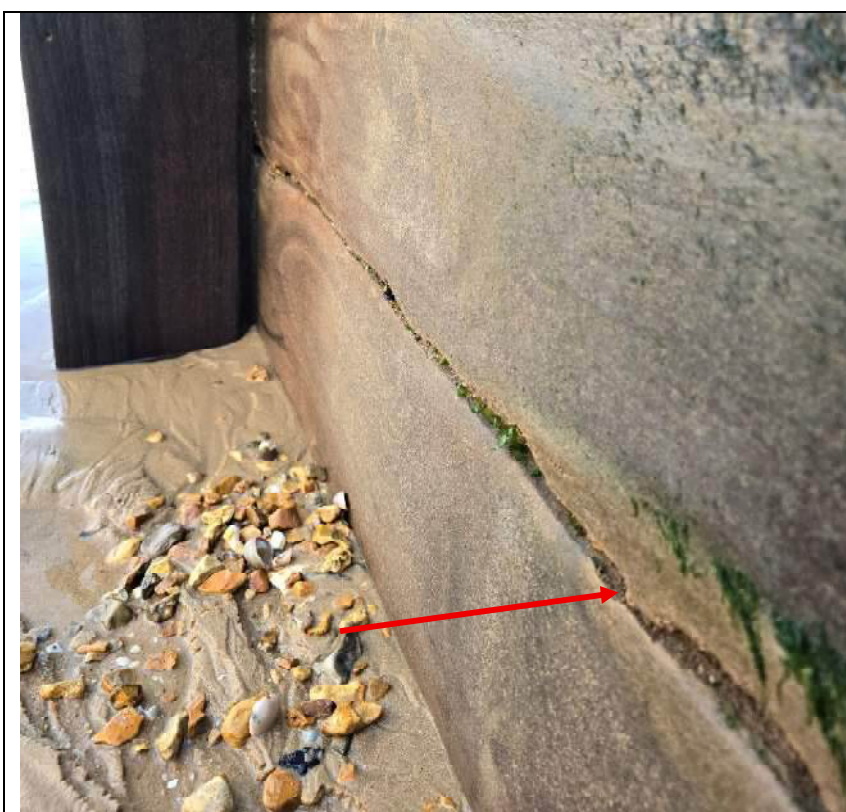
**Plate 41** - Groyne 30. Gribble attack observed at the edge of a plank (indicated). The localised nature of the damage and minor loss of section at the edge of the plank results in a visual assessment rating of '2'.

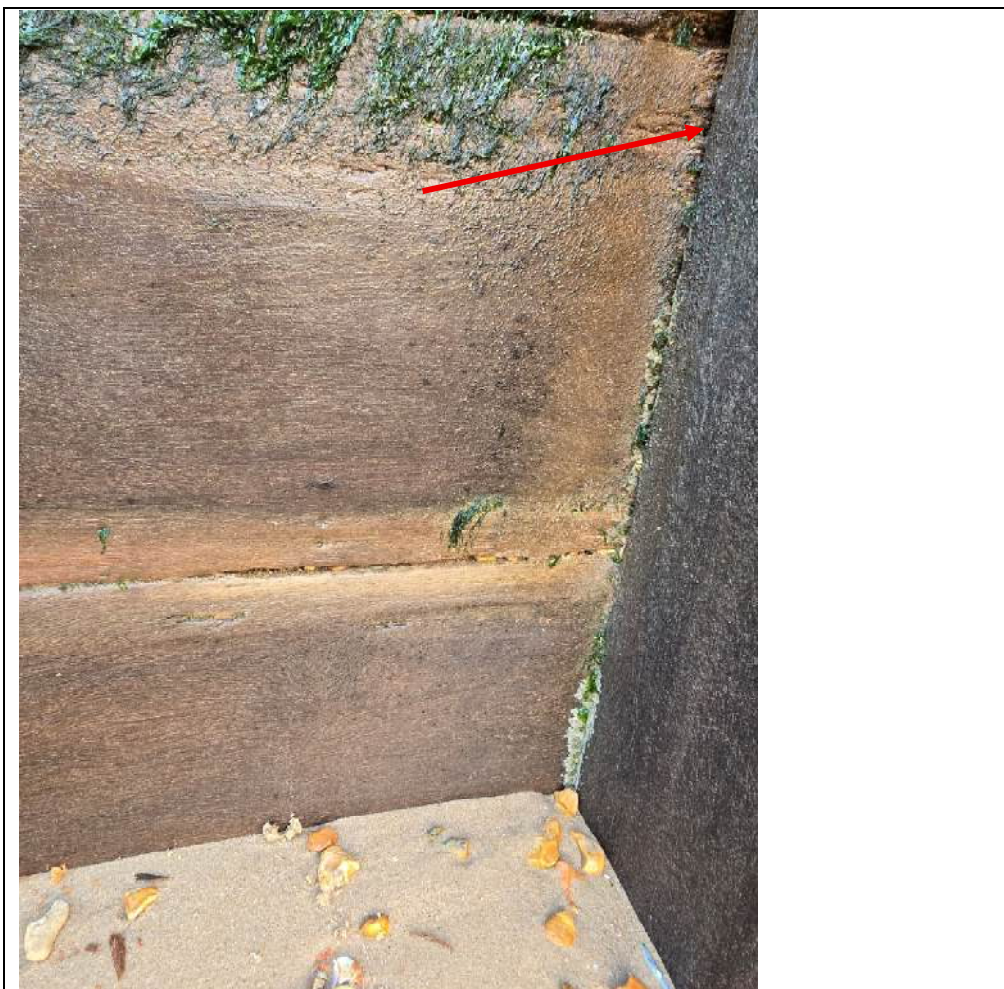
**Plate 42** - Groyne 30. Gribble attack observed at the edge of a plank adjacent to a pile on the seaward elevation (indicated). The localised nature of the damage and minor loss of section at the edge of the plank results in a visual assessment rating of '2'.
