Migration of Gravel Barriers over a Consolidating Substrate: Implications for Coastal Management.

Lauren Burt BSc (Hons)

MSc Engineering in the Coastal Environment

December 2016

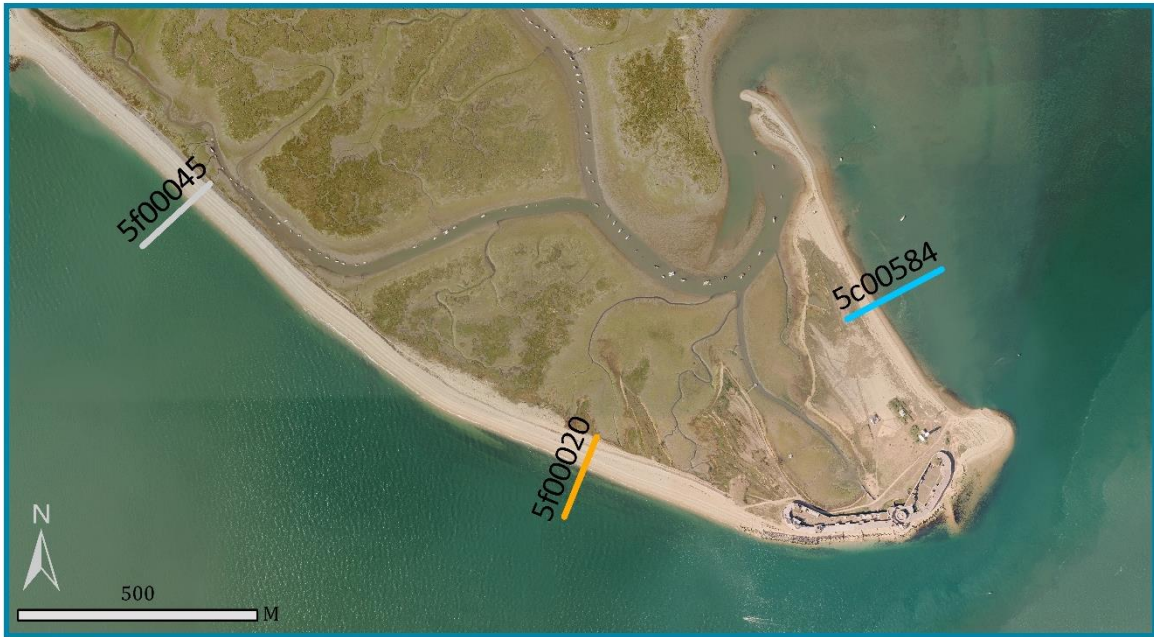
Figure 5: Map to show the locations of three key coastal monitoring profiles, to demonstrate the variability in cross section along the length of Hurst Spit. Aerial photography (2016) (C) NFDC, courtesy of the Channel Coastal Observatory.

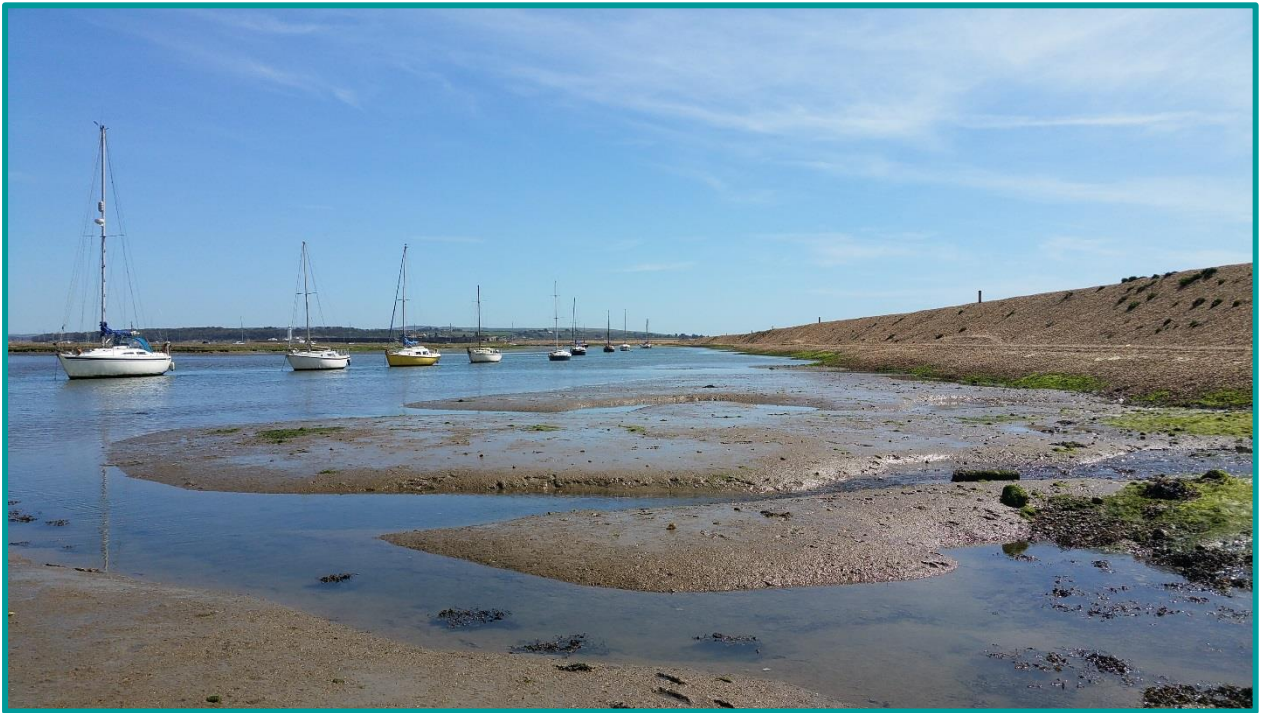
Figure 7: A view southeastwards along Mount Lake towards Hurst Castle, from the lee of Hurst Spit, showing the poorly consolidated material of the Keyhaven intertidal mudflats.

In the lee of Hurst Spit lies the Keyhaven Saltmarsh, with areas of saltmarsh vegetation separated by a well-developed creek system and mudflats including the channel at Mount Lake. Hurst Spit has been rolling back over these sediments, and therefore the substrate beneath Hurst Spit is likely to be consolidated saltmarsh and mudflat deposits (Figure 7) overlying a gravel bed of 'Plateau gravels' (Nicholls, 1985).

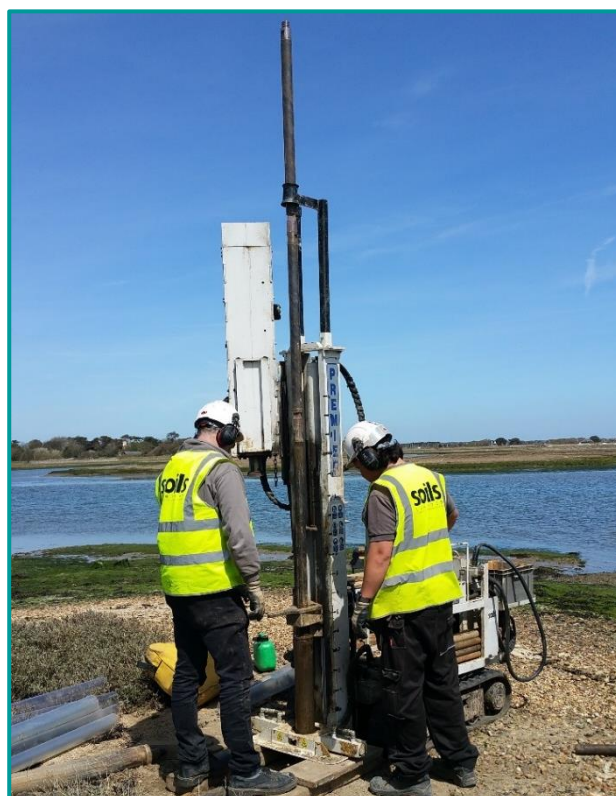
Figure 10: Image of drill rig at Hurst Spit, kindly provided by Soils Ltd.

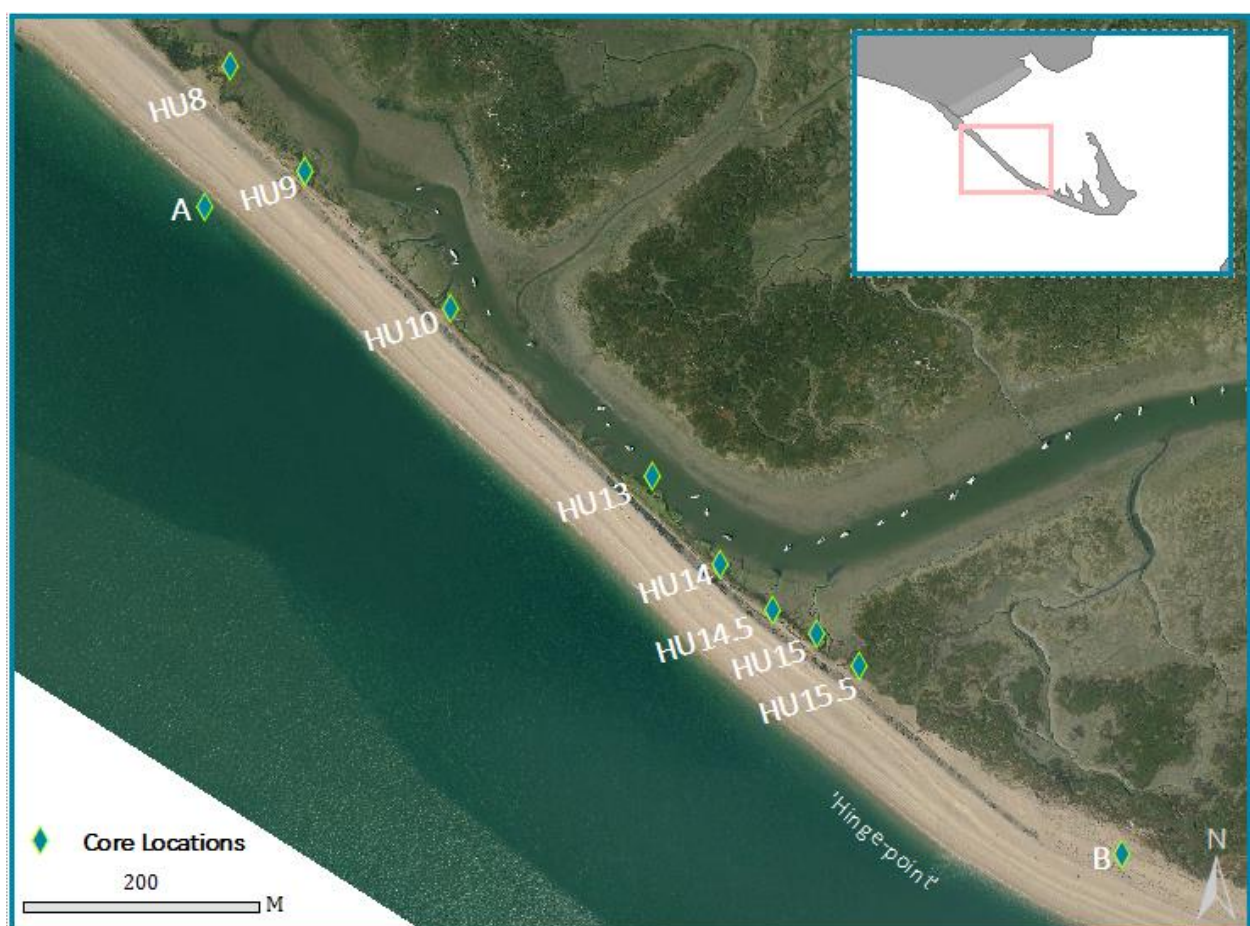
Figure 11: Map to show locations of cores. Aerial photography (2016) (C) NFDC, courtesy of the Channel Coastal Observatory.

The core locations are shown in Figure 11 and further detailed in Table 1.

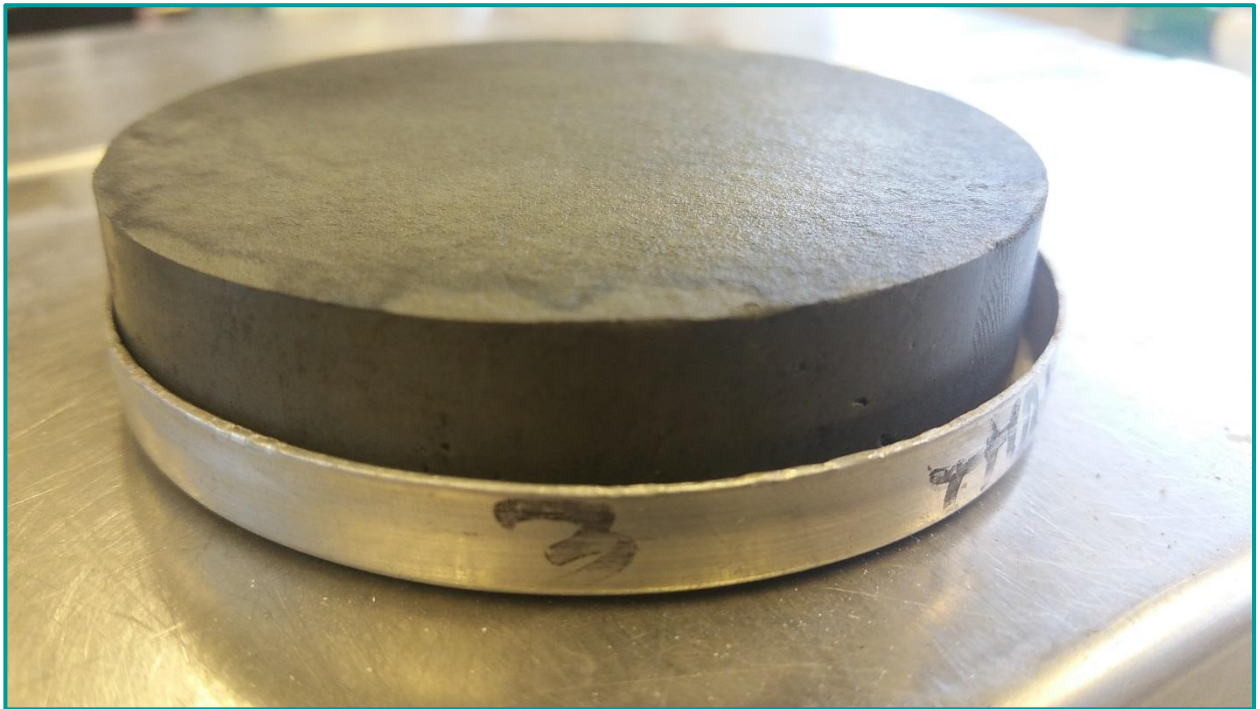
Figure 12: Example of the marine mud used for oedometer testing.

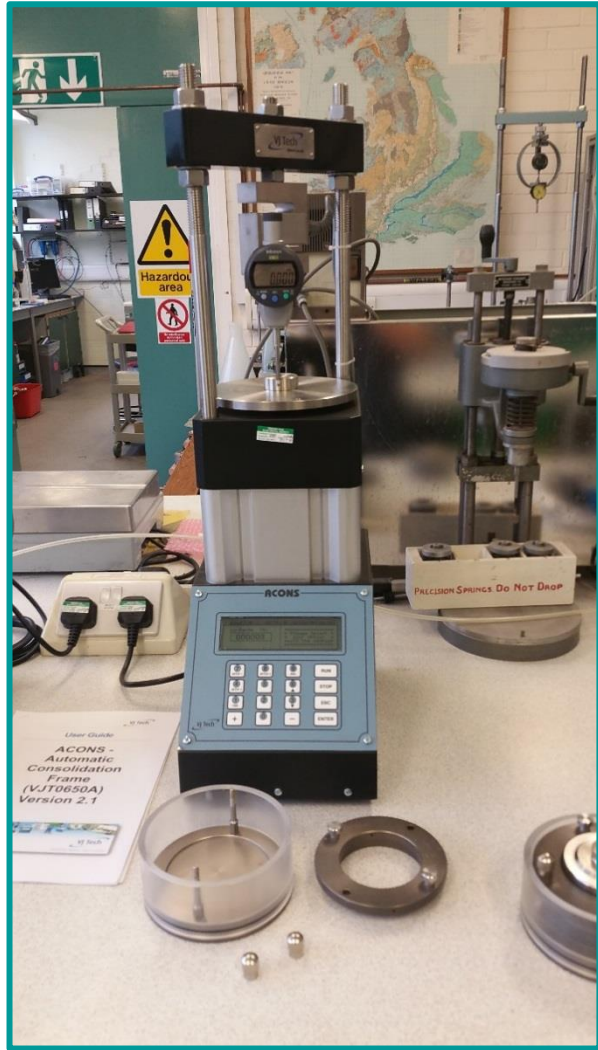
Figure 13b: Automatic Consolidation Frame.

These apply load with a load transducer, which compresses air to the required set Newtons (N) with automatic logging available for use. The traditional oedometer required samples of 50mm diameter and 76mm, with the ACF only able to take 75mm diameter samples. Samples were prepared using the following steps:

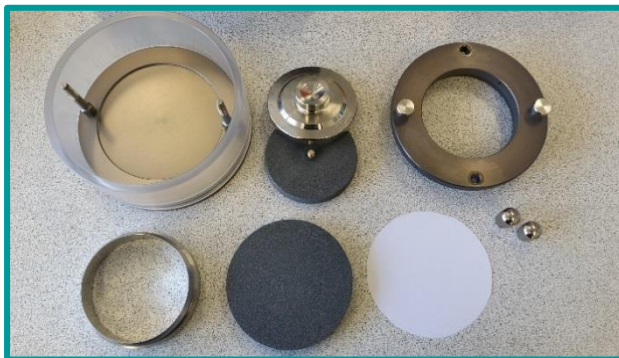
Figure 14a: Component parts of oedometer cell.

3. Weigh the consolidation ring containing the finally prepared sample. Add filter paper to the top and bottom.
4. Assemble the component parts (Figure 14a and 14b): retaining ring, consolidation ring porous discs, loading cap and set in place on the one dimensional consolidation device. Set up the displacement transducer and calibrate to zero.
5. Ensure the one dimensional consolidation device is calibrated for use.
6. Set up stopwatch, recording sheet and necessary loads required.

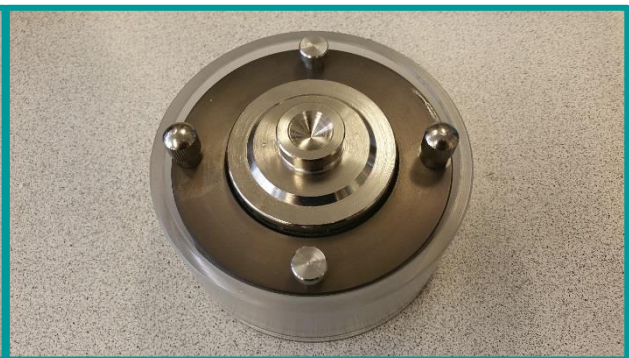
Figure 14b: Assembled component parts of oedometer cell.

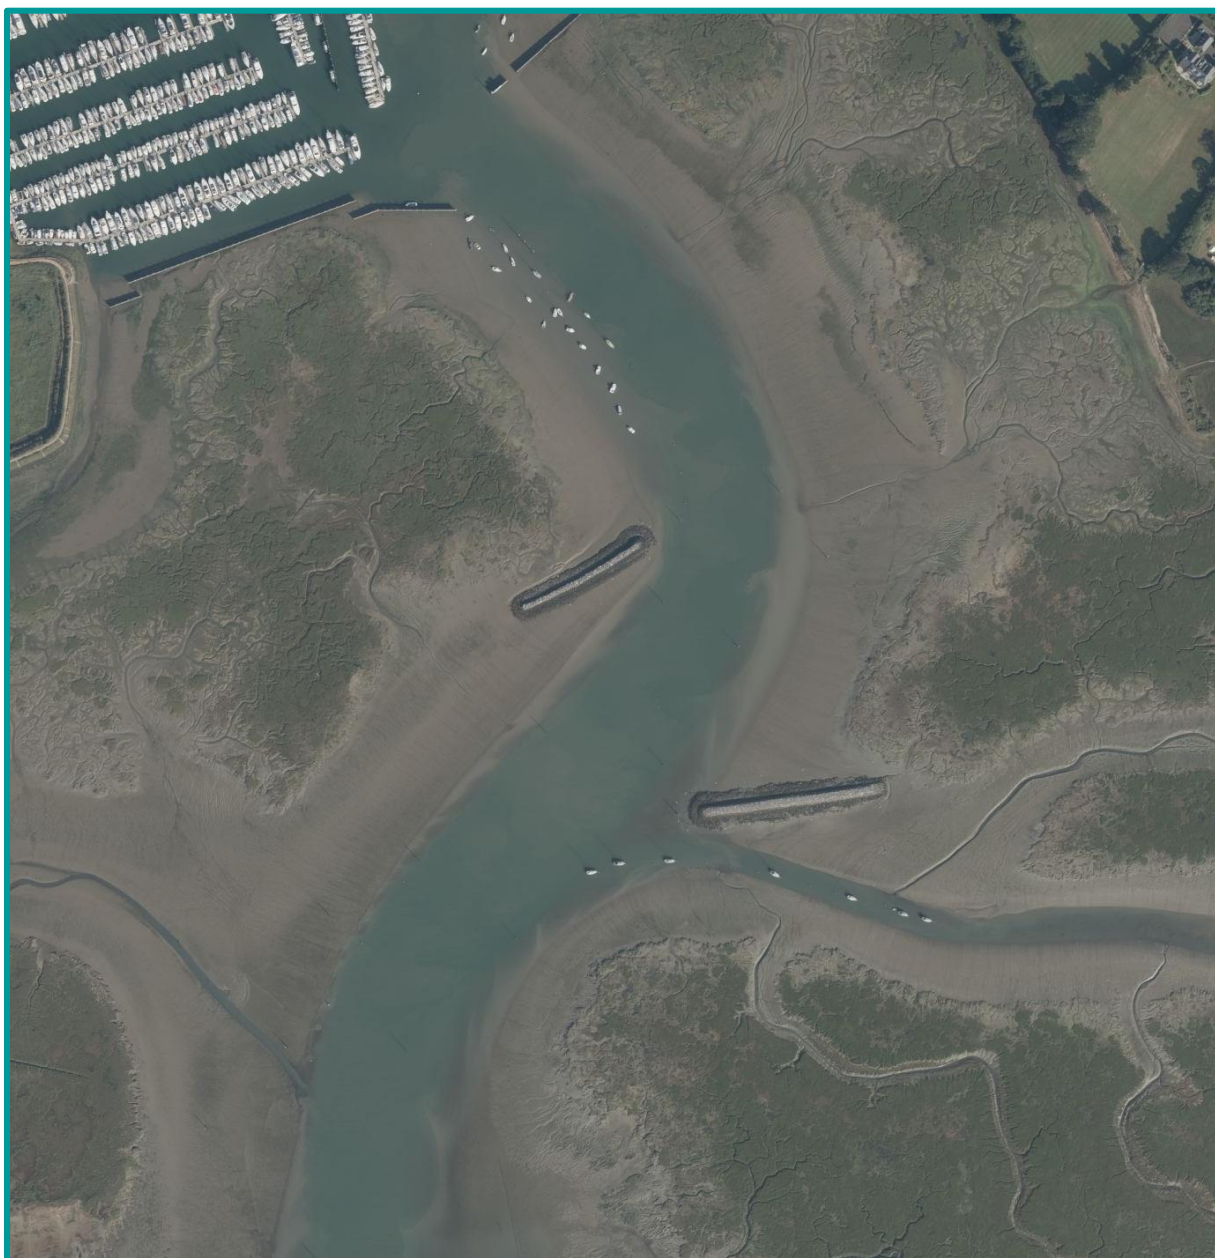
Appendix B. 2016 Aerial photography image of Lymington Phase I and II breakwaters (courtesy of Channel Coastal Observatory, 2016).
