The recent morphological evolution of Pagham Harbour entrance and the cause of the breach to Church Norton spit in Winter 2016

Emma Harris
19th January 2018

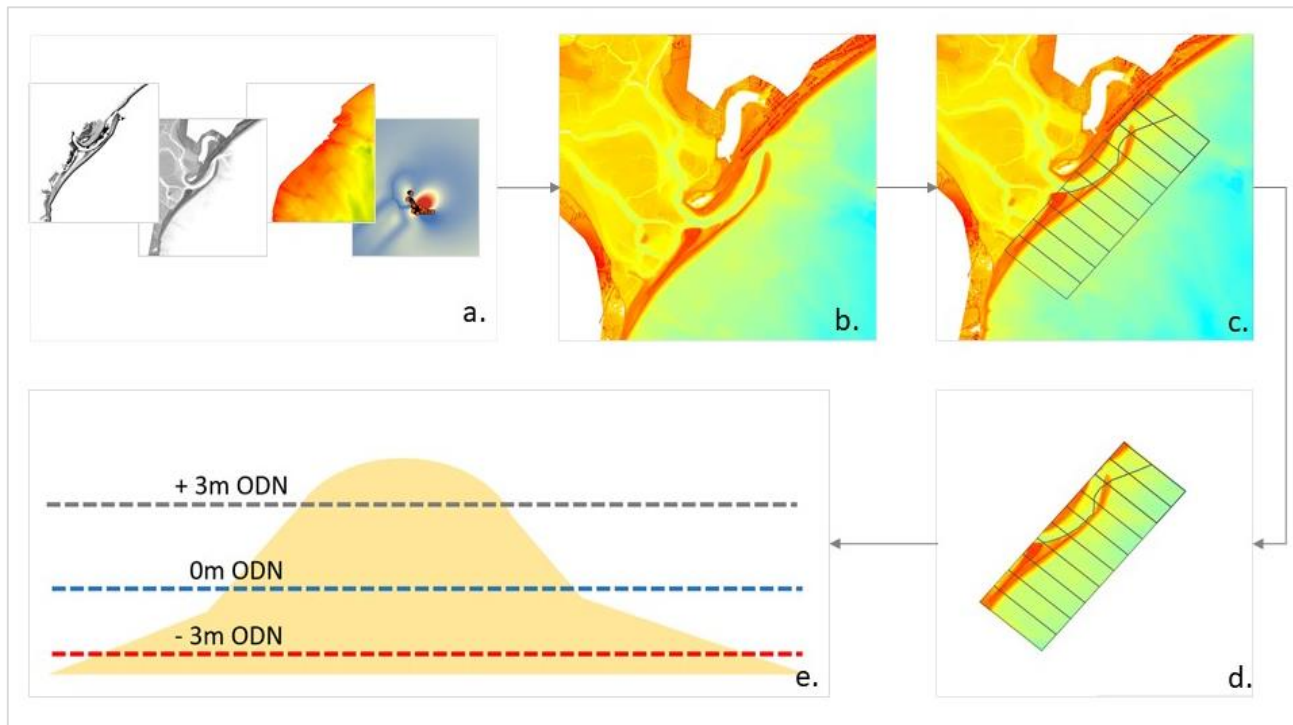
4. Methodology

1. GIS analysis:
- 27/01/2015 to 03/03/2017
