Migration of Gravel Barriers over a Consolidating Substrate- Implications for Coastal Management

Lauren Burt

New Forest District Council

Hurst Spit – Study Site

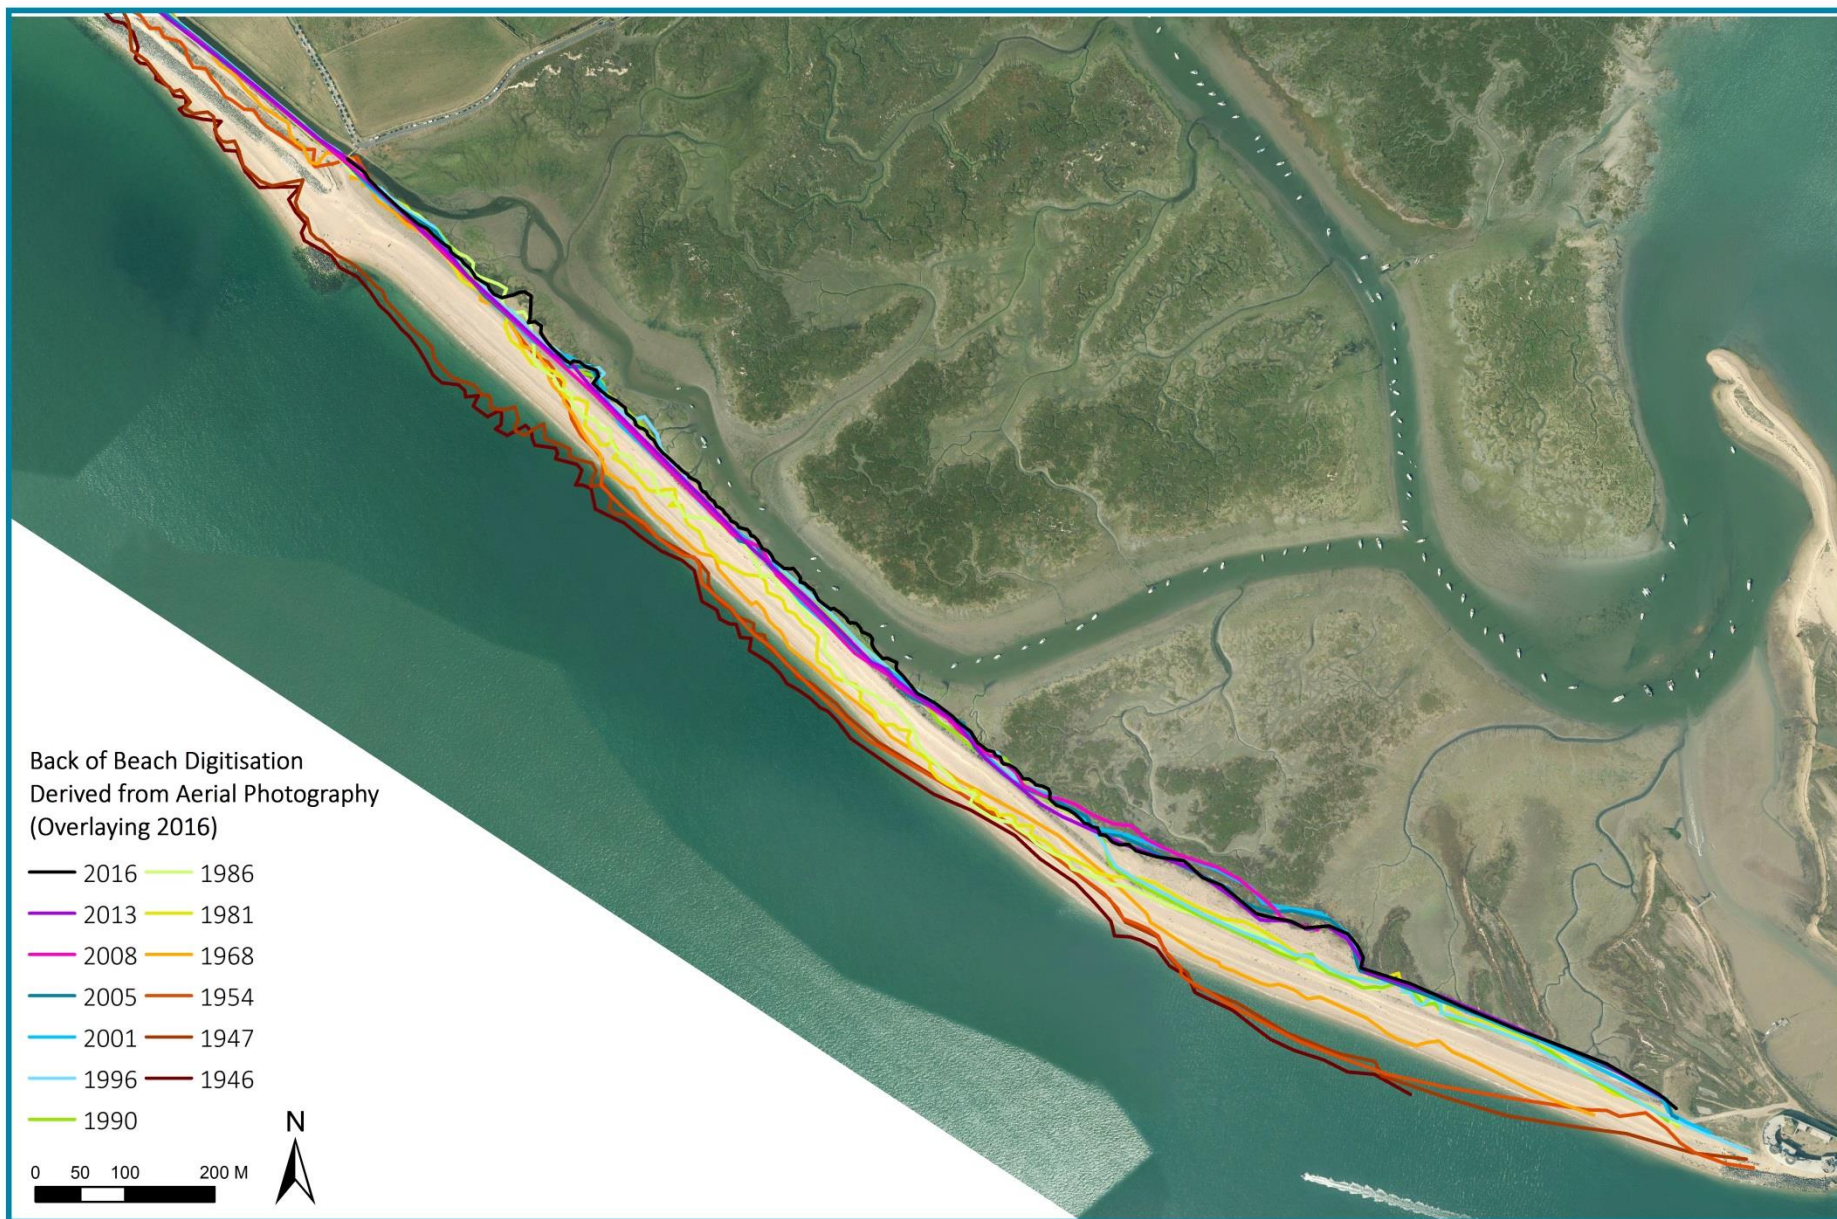
Back of Beach Digitisation
Derived from Aerial Photography
(Overlaying 1946)
